SANDIN E. PHILLIPSON, PH.D.

August 16, 2019

Slope Stability of the Ridge
Bounded by
Woodsdale, Waddles Run, and SR88

Previous Mining and Mine Subsidence Potential

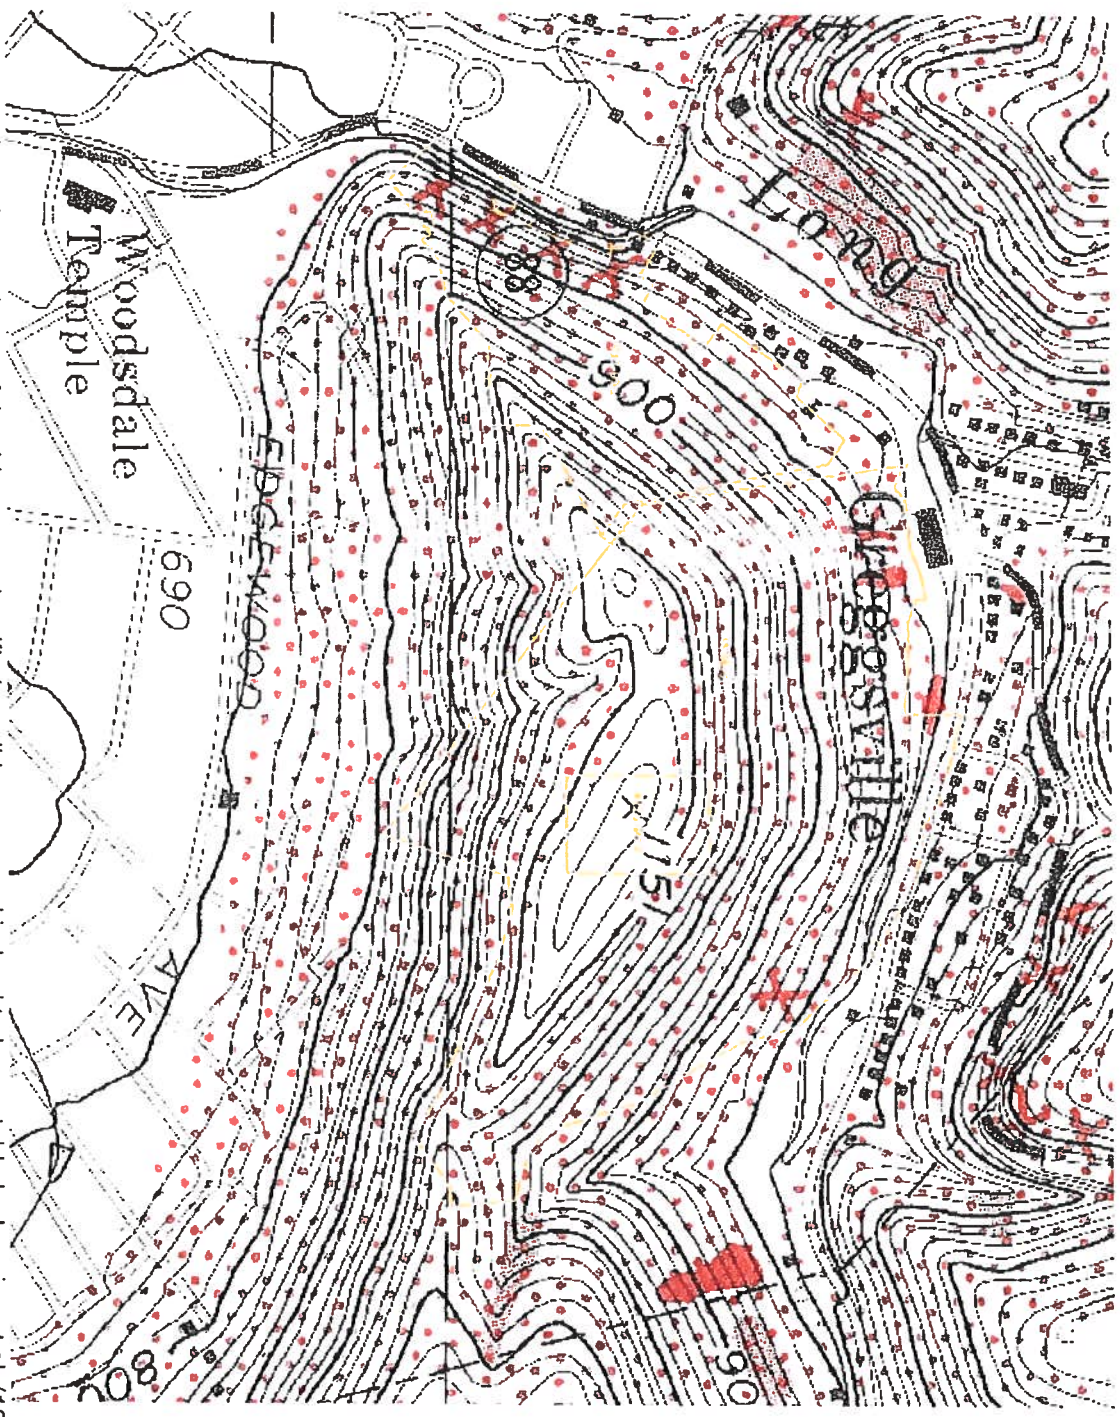
Figure 2. The north, south, and west slopes of the ridge were classified as slide-prone and judged to be unstable by Lessing et al. (1976) as represented by stippled pattern. Pink areas represent older landslides; large red X's represent rock falls; red areas represent recent landslides as of 1976. Parcel outlines are shown for comparison.

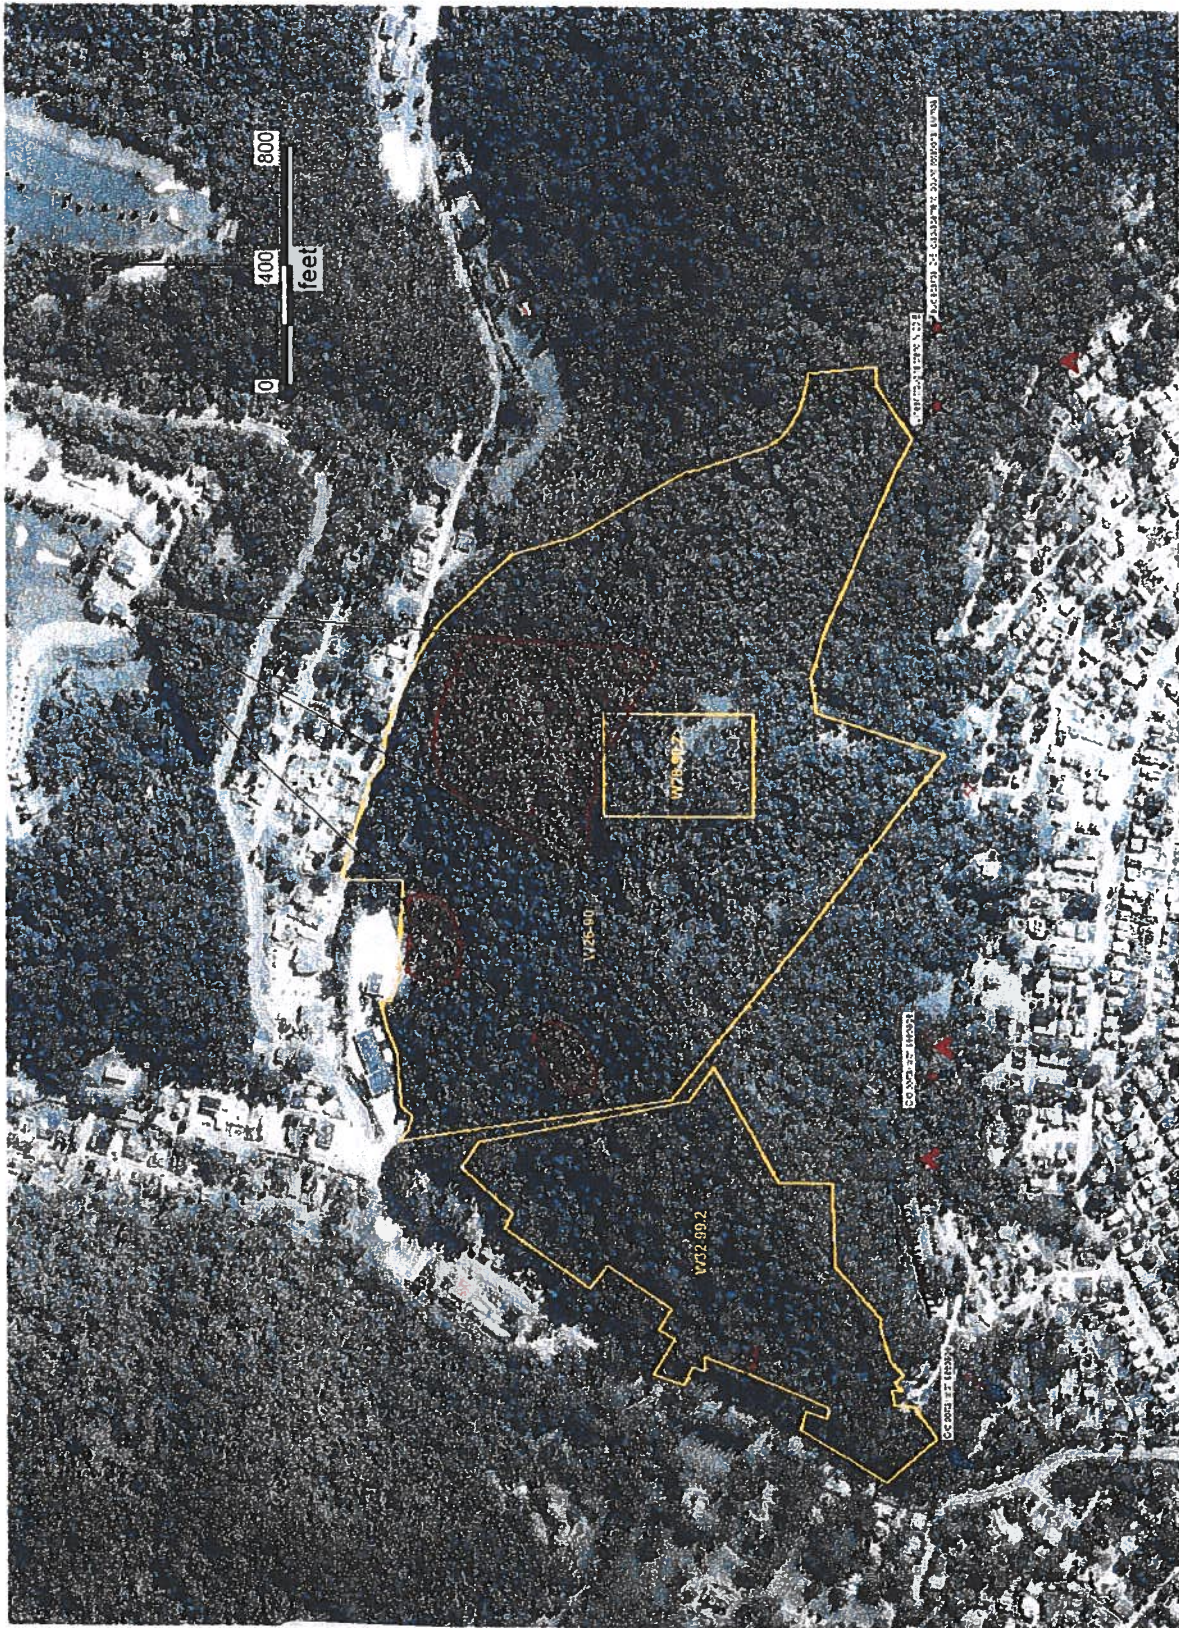
Although the northern and western slopes could not be directly accessed because of respect for private property, they can be viewed from ridge tops on the opposite side of Waddles Run to gain a broad, panoramic perspective. Several large failures, which appear to represent earthflows, are present on the north slope of the ridge, and may have occurred after rains associated with Hurricane Ivan in 2004 (Figure 4). The largest such earthflow is estimated as 800 feet in width, extending for virtually the entire height of the slope (Figure 5). The earthflow truncated the former access road to the top of the ridge, and also truncated at least 5 former logging roads arrayed along horizontal terraces on the side of the ridge (Figure 6). It should be noted that in the summer of 2014, the truncated former logging road was re-established by earthmoving equipment, thereby undercutting the toe of the large earthflow. Because of extensive tree removal conducted on the northern slope during the summer of 2013, the approximate top 60 feet of elevation has been virtually denuded, and the toe of a small earthflow appears to have truncated the highest former terrace (Figure 7). Figure 8 represents what appears to be a debris flow, composed of jumbled rock and mud on the slope above the current C-3 Church in an area of extensive tree removal. This feature may, however, represent bulldozer activity from 2013.

Figure 4. Landslides (red stipple) are shown from remote observations along with the parcel boundaries. Extensive tree removal has been performed since this aerial photo was taken in 2009.

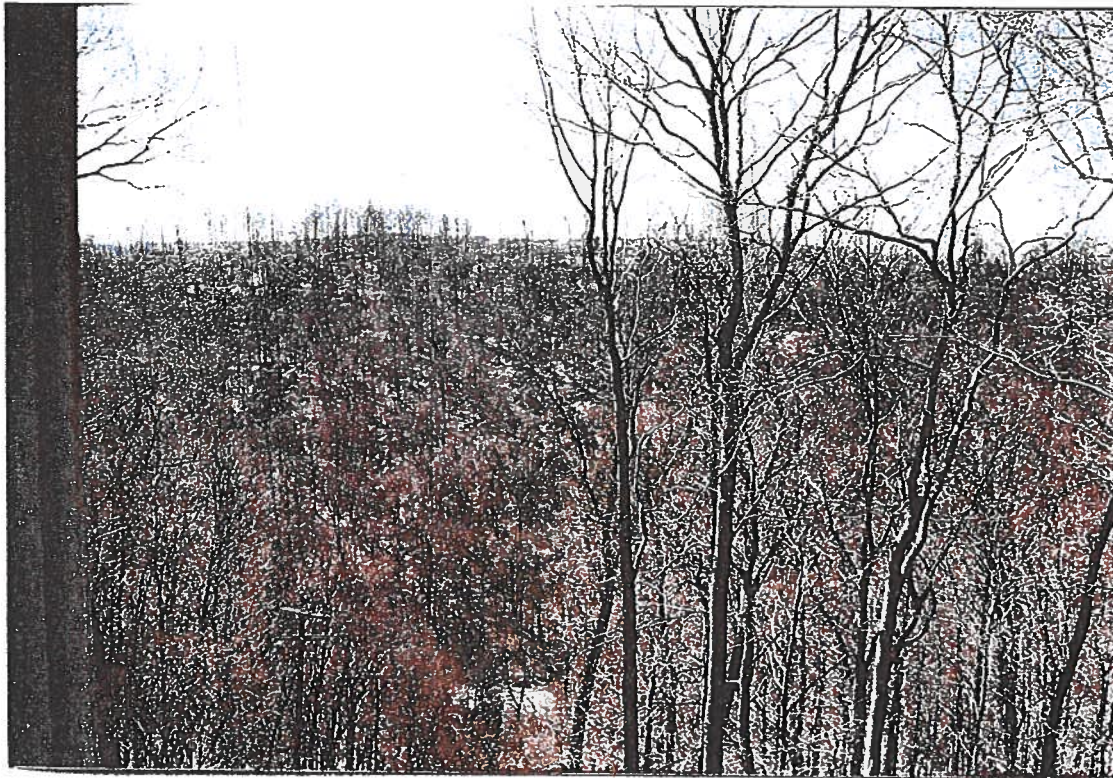
Figure 5. Large earthflow truncates horizontal terraces for nearly the fully height of the north ridge slope.

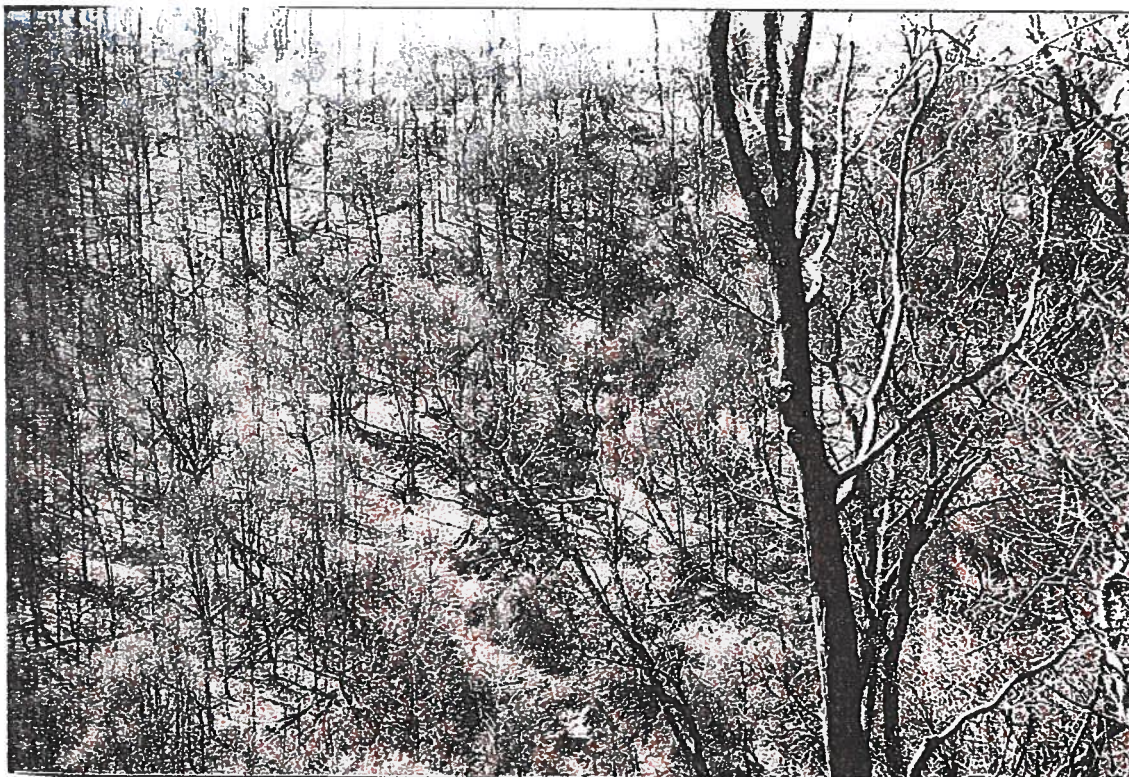
Figure 6. The eastern edge of the earthflow in Figure 5 truncates two former logging terraces, recognized as light-colored, horizontal surfaces.

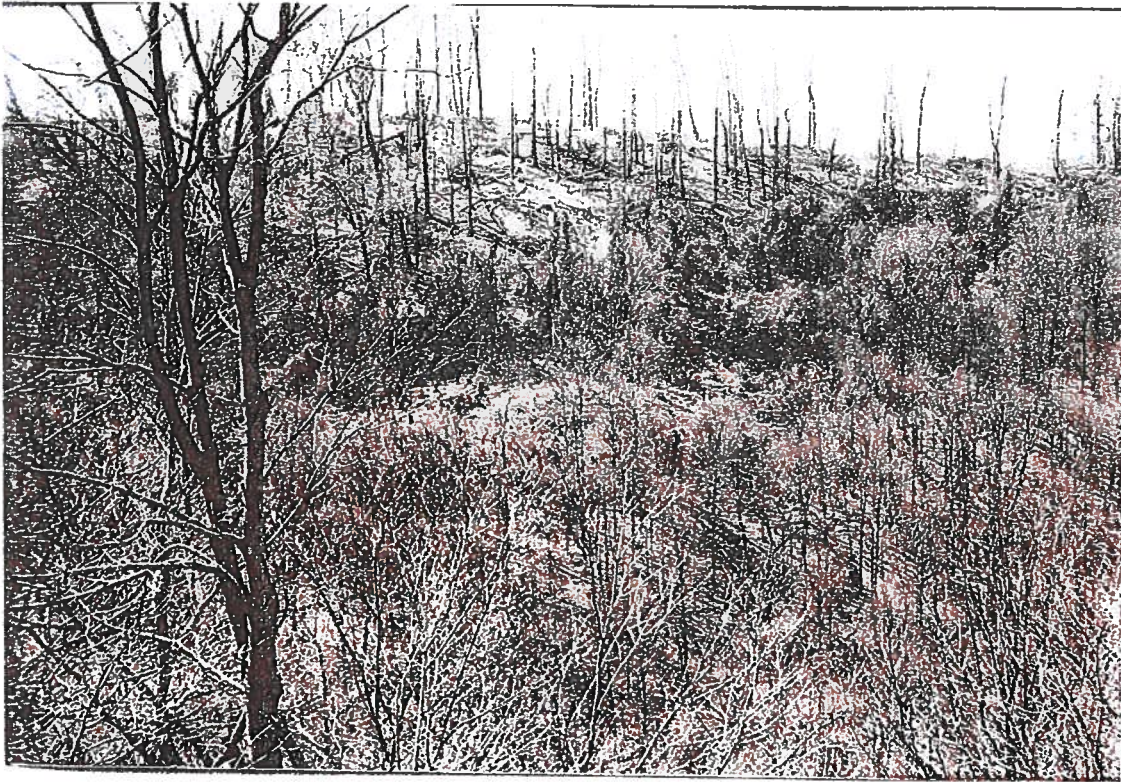
Figure 7. The toe of a small earthflow truncated the top logging terrace beneath an area of denudation.

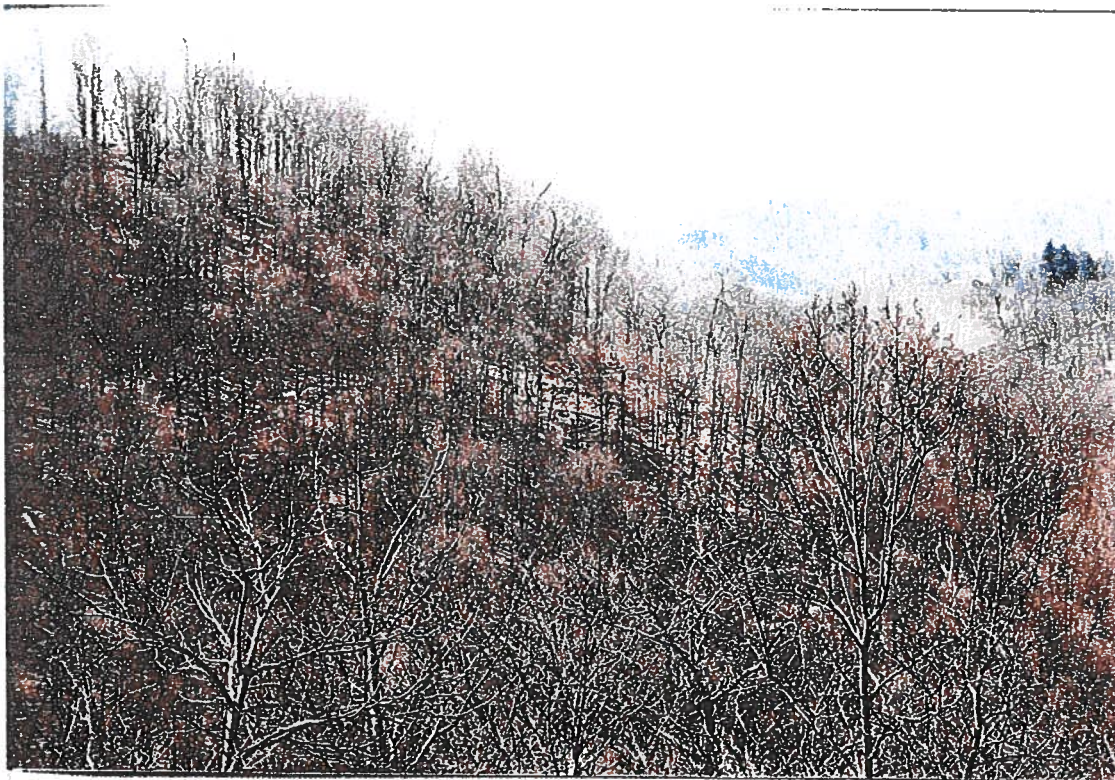
Figure 8. Jumbled rocks and mud (light brown patch) occur on the nose above the C-3 Church.

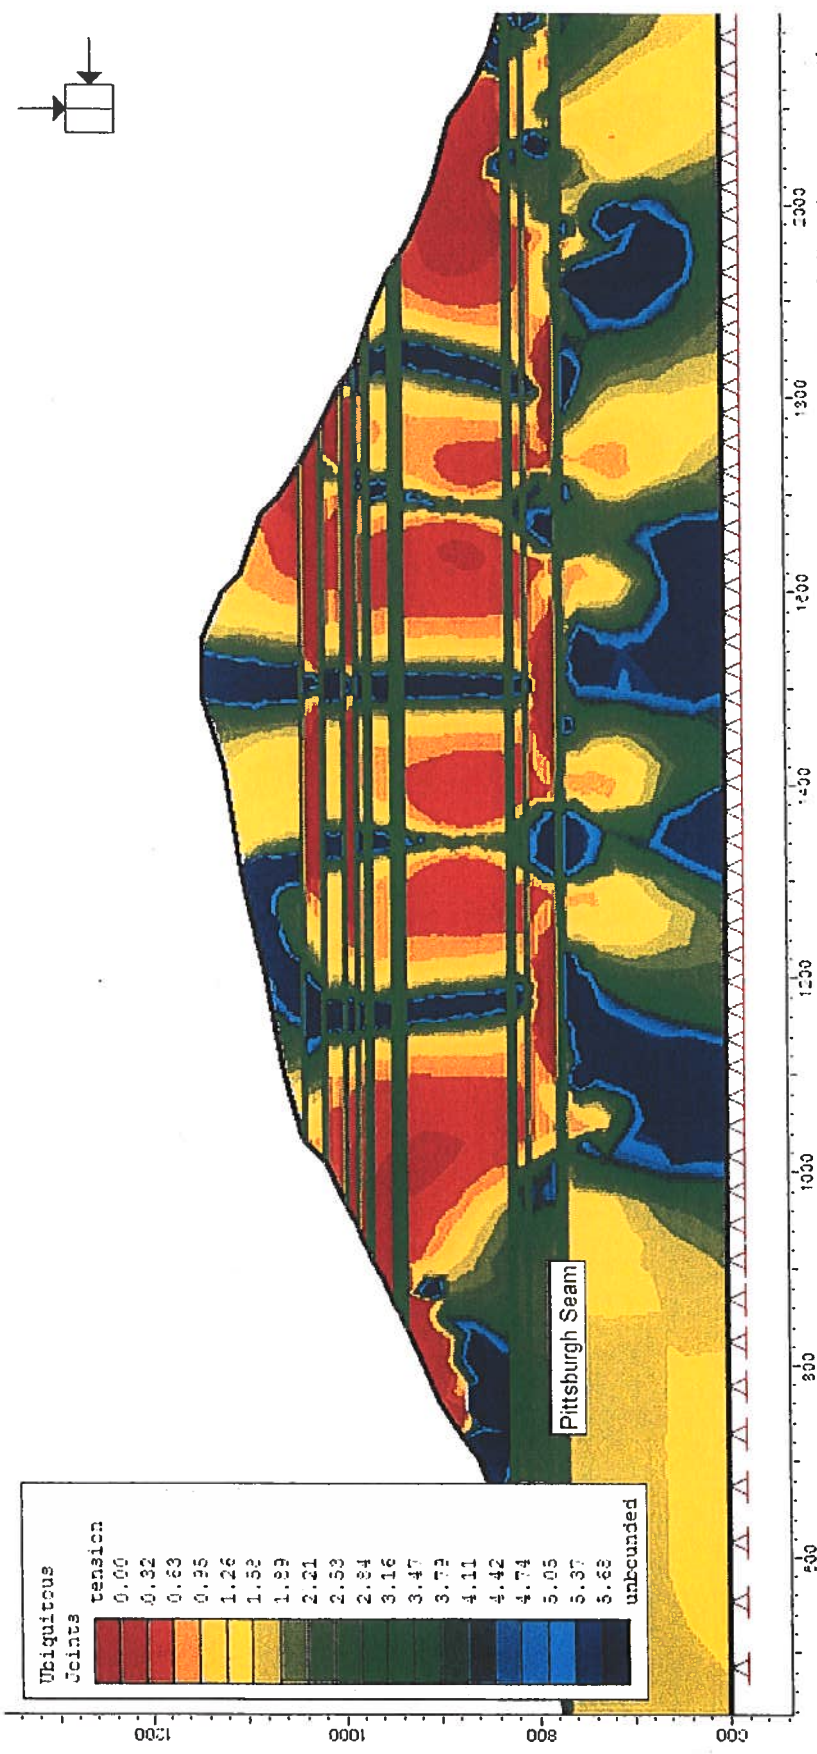
Figure 11. The distribution of values of "Strength Factor," an indication of failure for values less than 1, following extraction of coal from the production panels flanking the 2-entry haulageways and assuming the presence of vertical joints in the rock mass. Zones of failure along vertical joint zones, indicated by "hot" colors, extend to the surface as an indication of shear failure through the overburden and settling of joint-bounded blocks into the underlying mine voids.

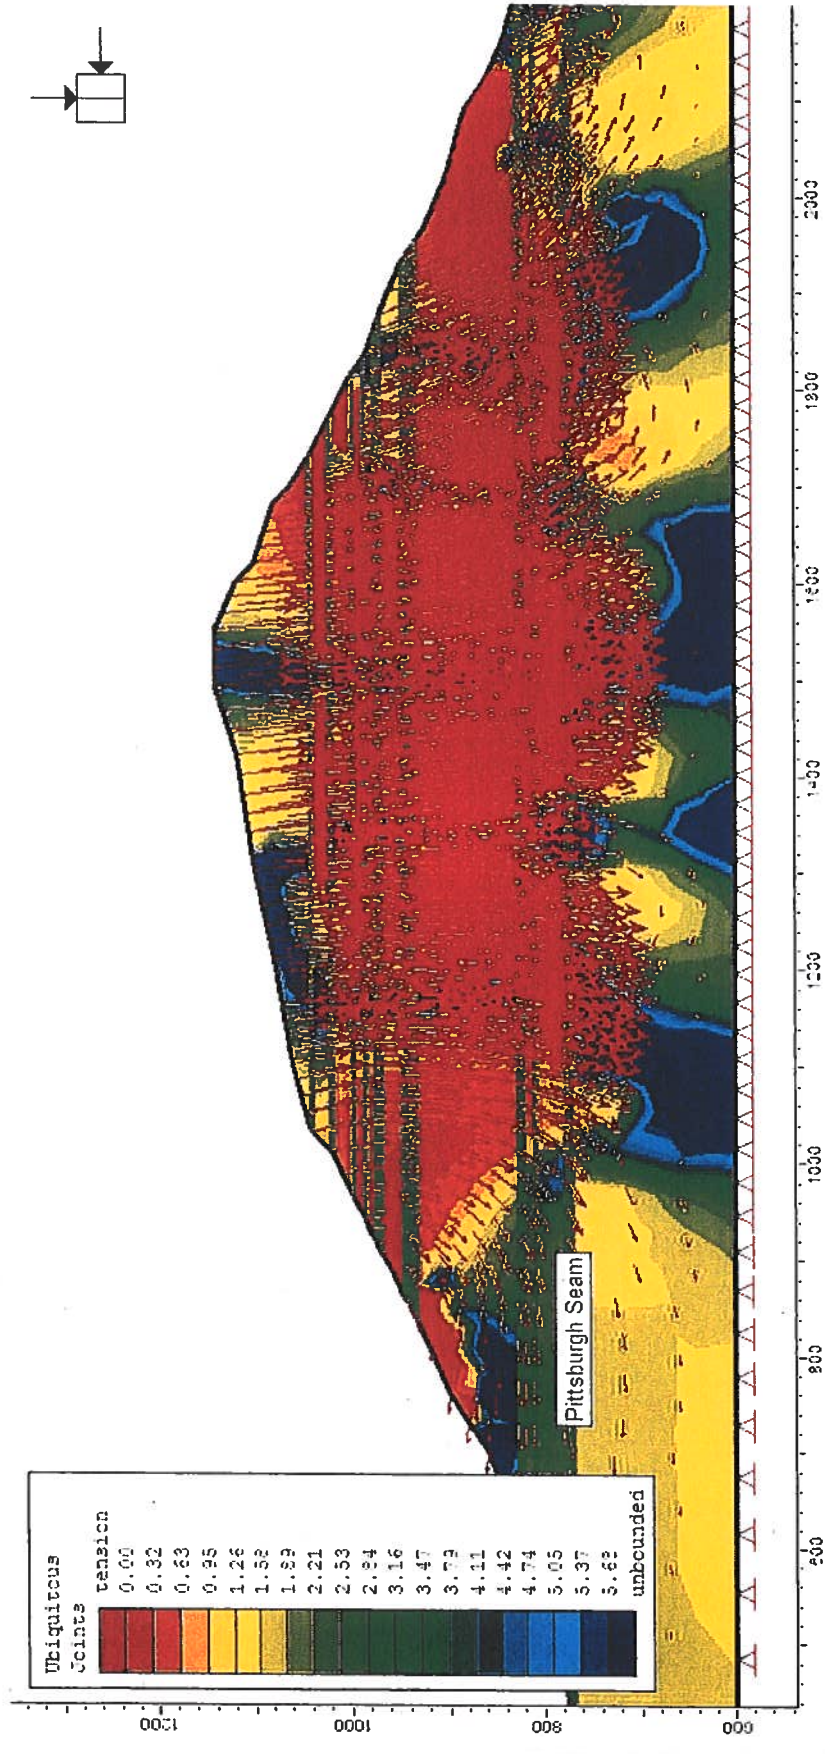
Figure 12. The distribution of values of "Strength Factor," an indication of failure for values less than 1, following extraction of coal from the production panels flanking the 2-entry haulageways. Stress vectors (downward-pointing arrows) indicate the overwhelming tendency for subsidence into the underlying voids.

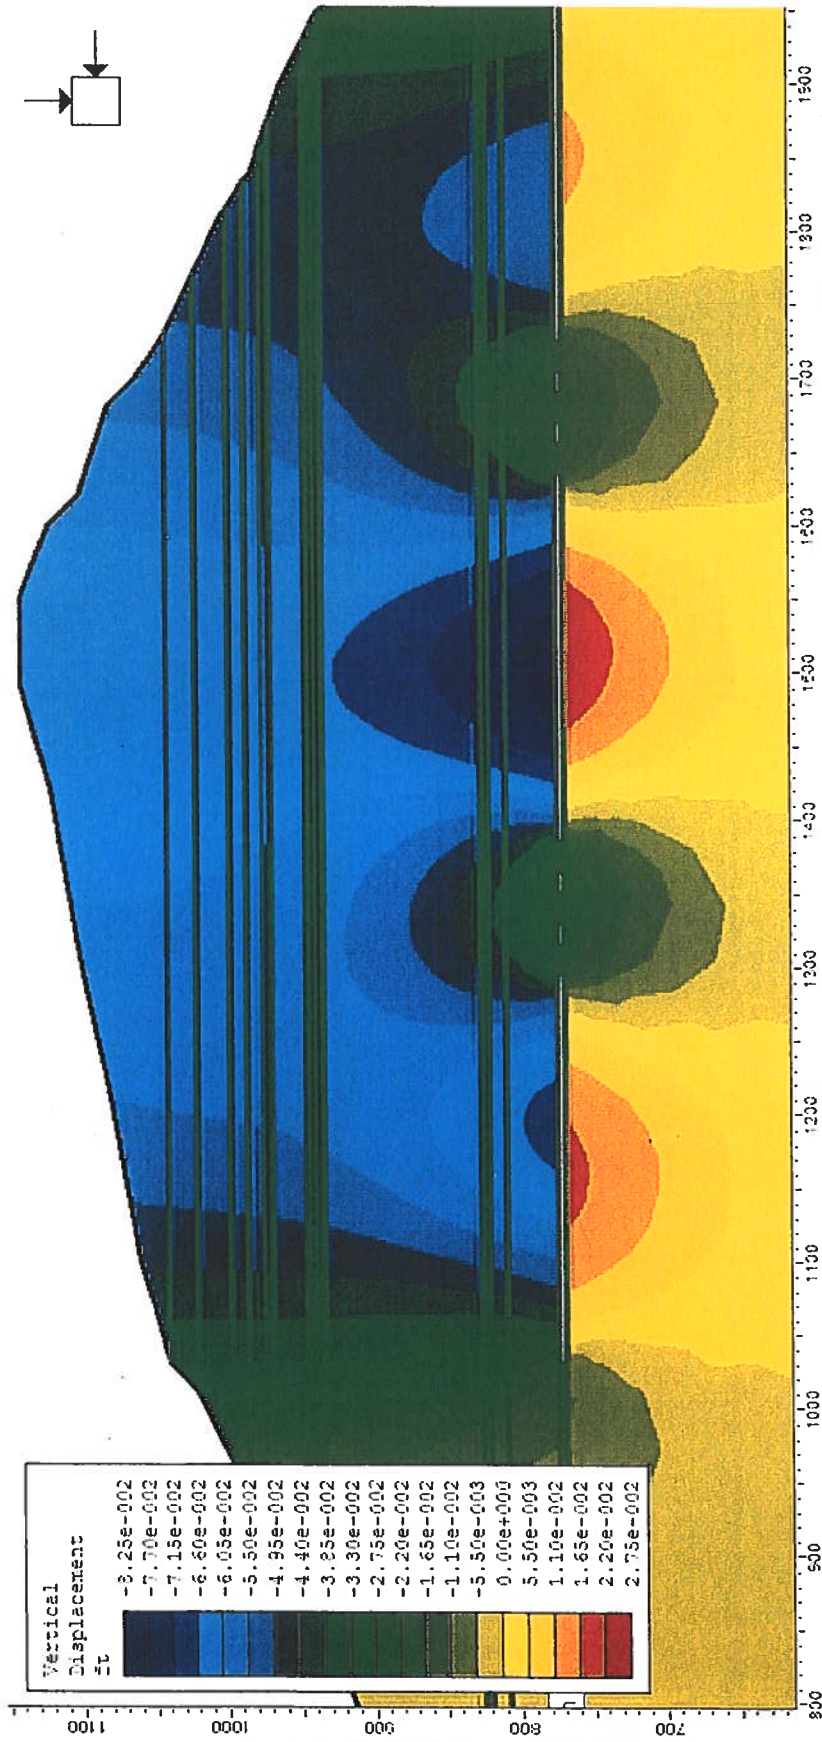
Figure 13. The distribution of values of Vertical Displacement after mining the production panels and creating 250-foot wide voids separated by the composite barriers protecting the 2-entry haulageways. The "cool" colors represent negative, in other words downward, displacement, indicating that the spine of the ridge is predicted to subside into underlying voids.

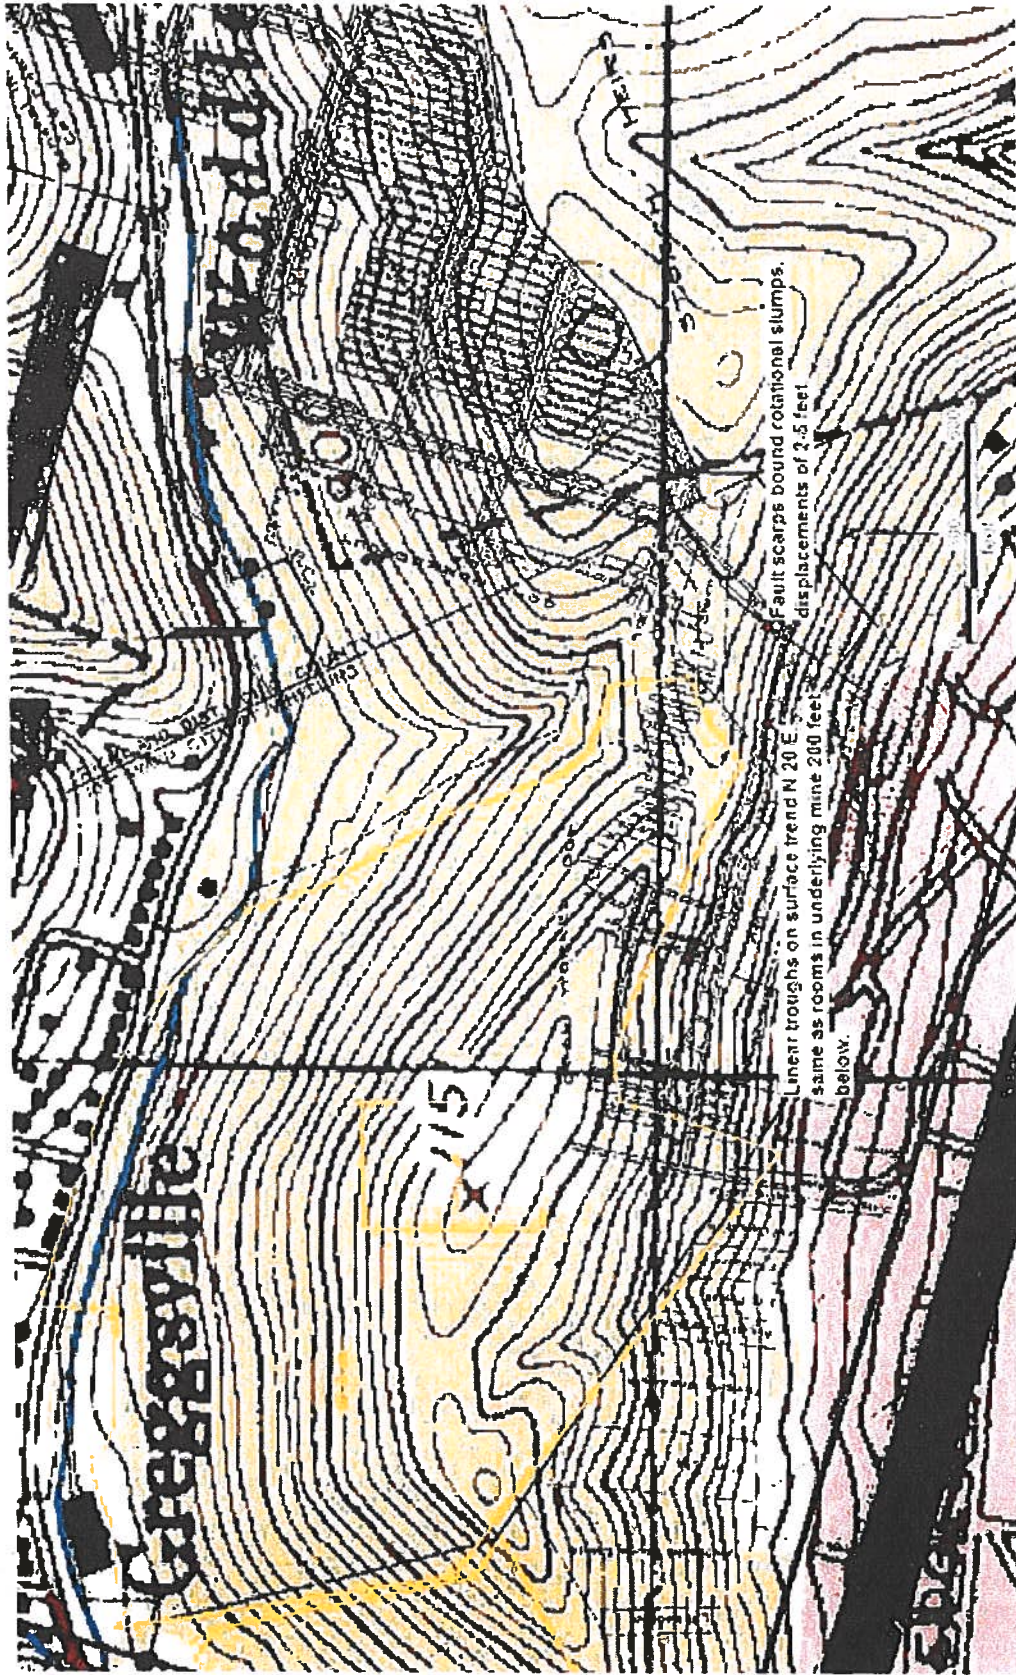
Figure 14. The outline of parcels W32-99.2 and W26-90 are superimposed on a map of the Pittsburgh-Wheeling Coal Co.'s Edgewood Mine, showing in relation to a topographic map for orientation. Text on the map describes mine subsidence-related features located with a GPS on the south side of the ridge, corresponding to the margin of the underlying mine.

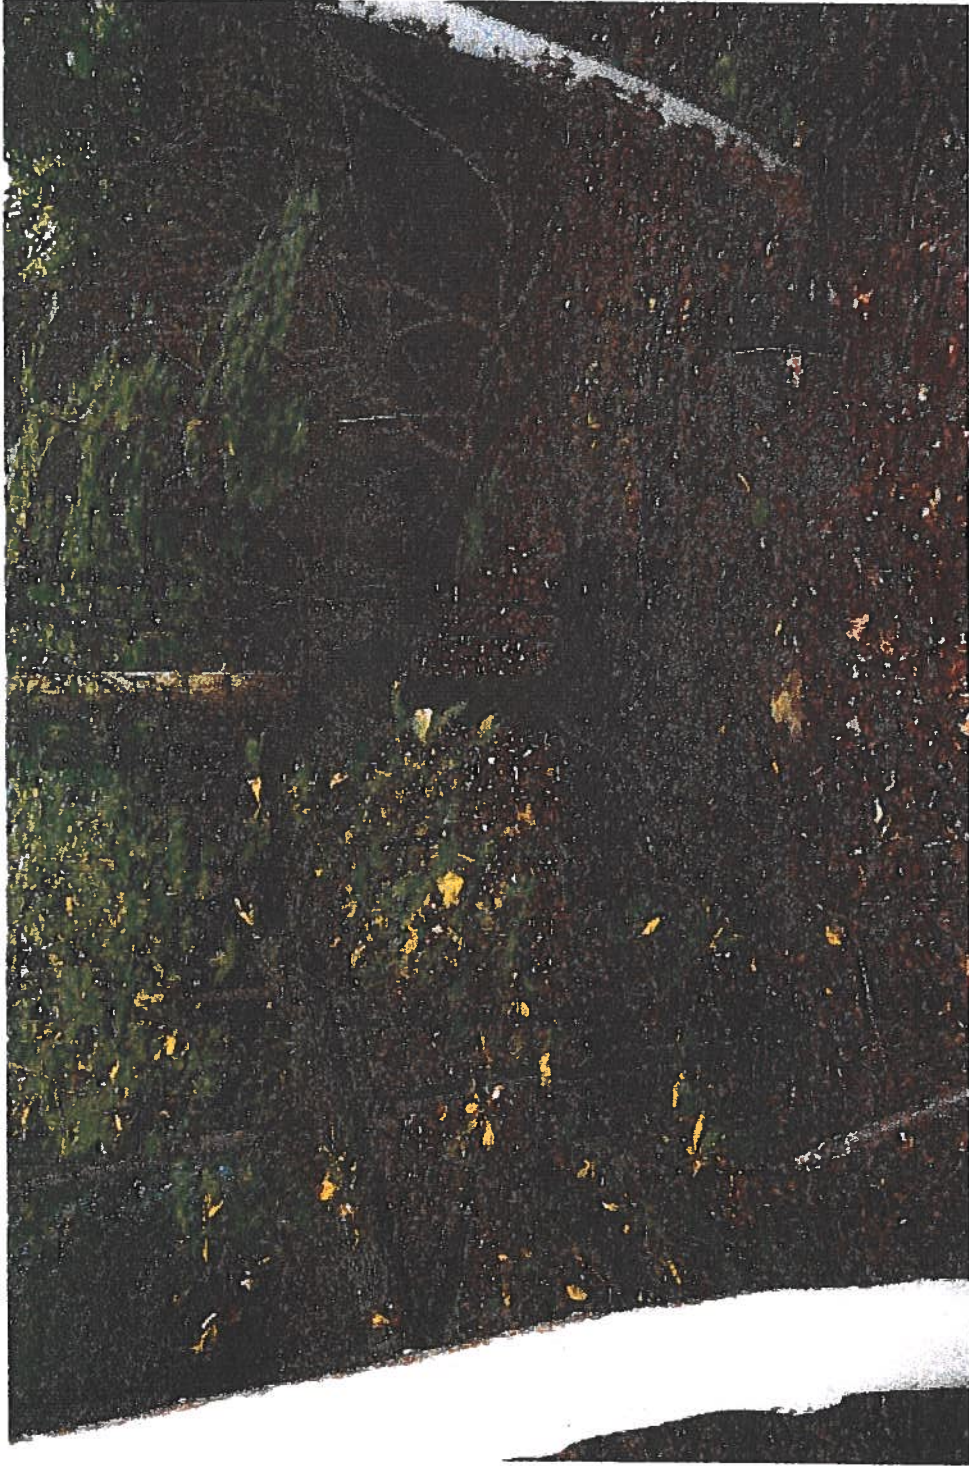
Linear trough observed on the ridge slope 200 feet above the Pittsburgh-Wheeling mine trends N 20° E, the same orientation as rooms and fenders in the production panels.

Figure 15. A linear trough, trending from the photo's left across the center of the field of view, is oriented with its long axis along a bearing of N 20° E, which is parallel to the long axis of rooms mined in the underlying Pittsburgh-Wheeling Coal Co.'s Edgewood Mine.

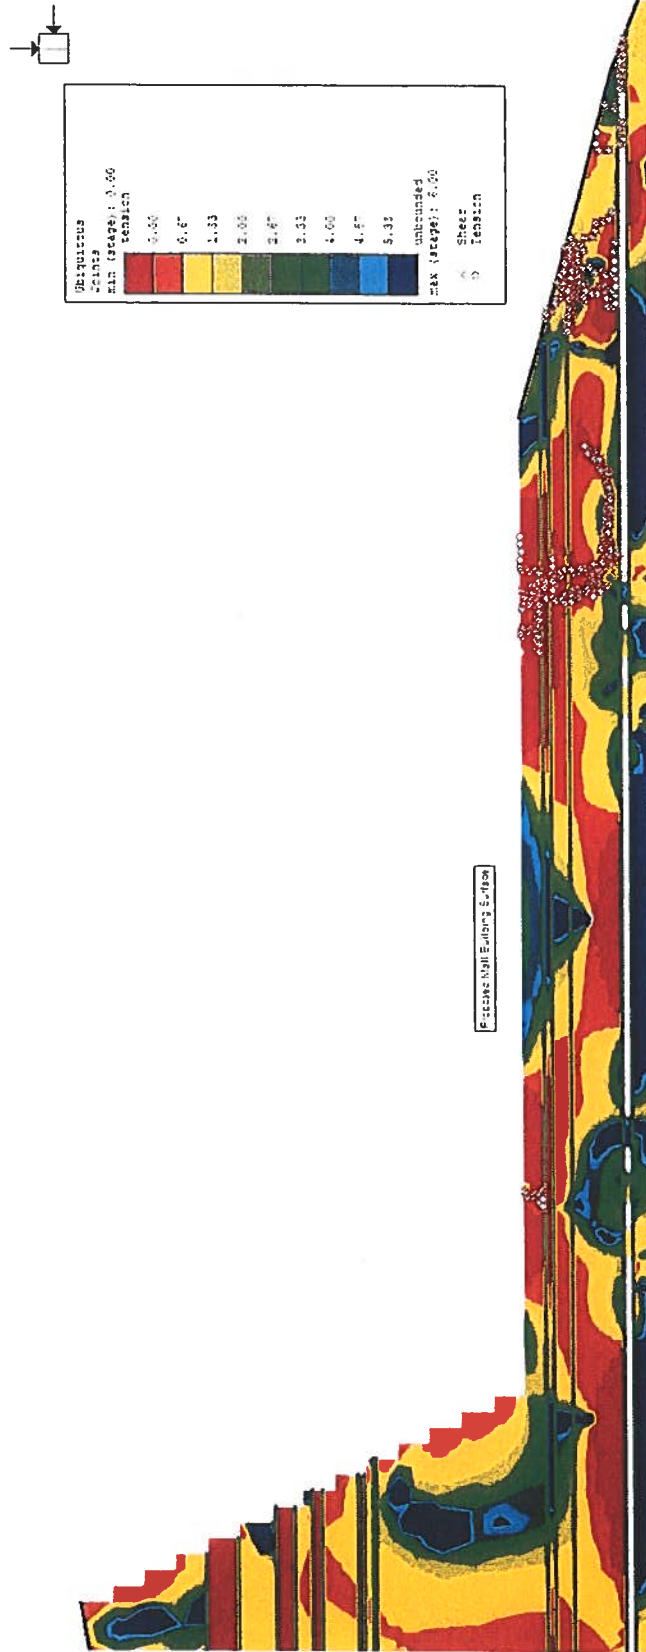
Figure 17. Distribution of Strength Factor for remaining strata above assumed mine voids in Pittsburgh Seam, suggesting potential for shear and tensile failure.

It should be recognized that simply because mining was performed approximately 90 years ago, there is no expectation that full convergence has already occurred. The foregoing analyses indicate only that pillars in production panels have very low stability and that collapse or failure is likely, but cannot predict when collapse will occur or even if it has occurred. However, if collapse has not already occurred, all indications are that it will. As presented in two articles from the Pittsburgh press, mines in the Mount Washington area of Pittsburgh have experienced mine subsidence and sinkhole development, with related damage to homes, since the 1950s (Appendices 4 and 5). Mine subsidence continues to the current time above the Pittsburgh Seam in this neighborhood, requiring the intervention of state-funded mitigation methods because of the vast scale and expense of measures to stabilize the ground. The only way to determine whether subsidence has not occurred, in other words that pillars are still intact and could fail in the future, would be through a program of core drilling and ground-penetrating radar to identify any existing mine voids.
