Reference: **Geotechnical Evaluation**  
**GC&P Development Planning Commission Application Review**  
Wheeling, West Virginia  
S&ME Project No. 1195-20-002

**Geotechnical Evaluation**  
**GC&P Development Planning Commission Application Review**

Wheeling, West Virginia  
 S&ME Project No. 1195-20-002

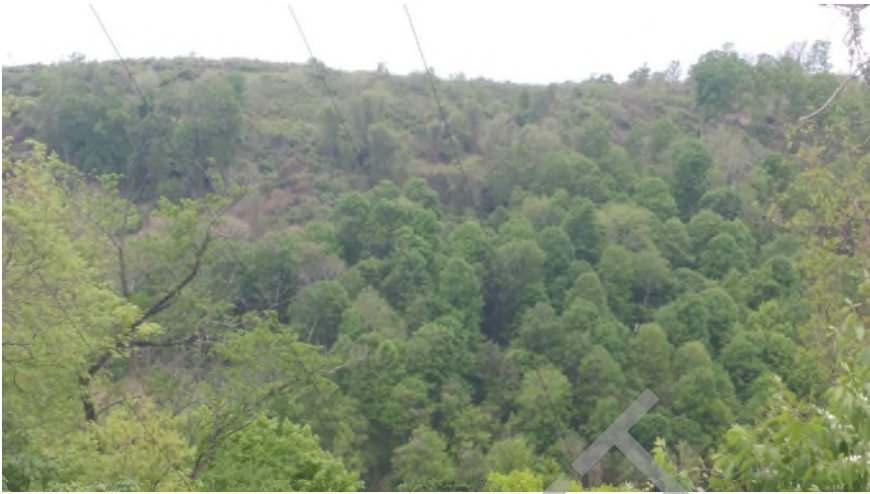
Date: 5/20/2020
			Photographer: Richard T. Wilson, PG
<b>1</b>	<b>Location / Orientation</b>	Overview of site	
	<b>Remarks</b>	Site mostly vegetated

Date: 5/20/2020
			Photographer: Richard T. Wilson, PG
<b>2</b>	<b>Location / Orientation</b>	Overview of the site	
	<b>Remarks</b>	Site partially vegetated

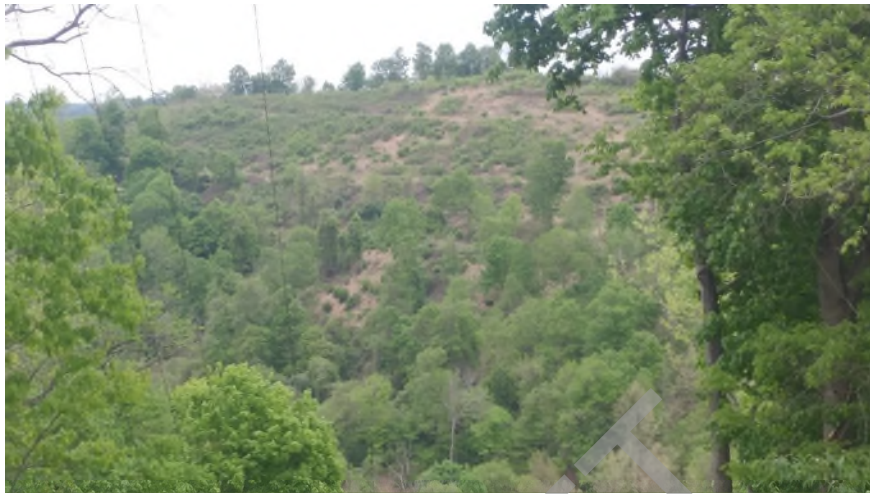
Date: 5/20/2020
			Photographer: Richard T. Wilson, PG
<b>3</b>	<b>Location / Orientation</b>	Overview of site	
	<b>Remarks</b>	Site partially vegetated

Date: 5/20/2020
			Photographer: Richard T. Wilson, PG
<b>4</b>	<b>Location / Orientation</b>	Behind 3C Church, near Station 20 of Profile C	
	<b>Remarks</b>	Acidic mine drainage

Mr. Richard T. Wilson, PG with S&ME performed a site reconnaissance on May 20, 2020. Mr. Wilson observed significant amounts of colluvium present at critical locations such as Pad A, Pad B, and the multiple entrance roads. Mr. Wilson also observed the presence of stained (orange) water seeping from the colluvium behind the 3C church. The presence of what could be acid mine drainage (AMD) may indicate the abandoned coal mine in the Pittsburg coal seam buried by the colluvium is introducing water into the colluvium. The water would tend to destabilize the soil slope. We are unable to provide an opinion regarding the quantity of the water present in the abandoned mine.

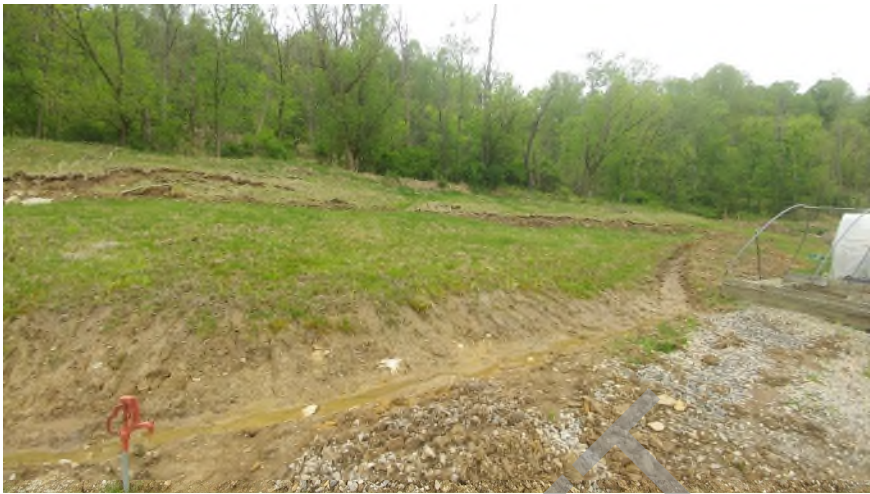
<b>5</b>	<b>Location / Orientation</b>	Base of hill near station 30 of Profile C
	<b>Remarks</b>	Colluvial deposits present

<b>6</b>	<b>Location / Orientation</b>	Behind Greenhouse off Waddles Run
	<b>Remarks</b>	Proposed revegetated slope with colluvial deposits

- ◆ Additional geotechnical exploration, testing and analyses are required for final design of cut slopes for the development .
- ◆ There is a large amount of colluvial deposits present within the area of influence on the proposed roadways, Pad "A" and Pad "B". We recommend these colluvial areas, and others if identified, that are impacted by the development and its associated activities be evaluated and specific design recommendations developed to ensure the long-term stability of the slopes.

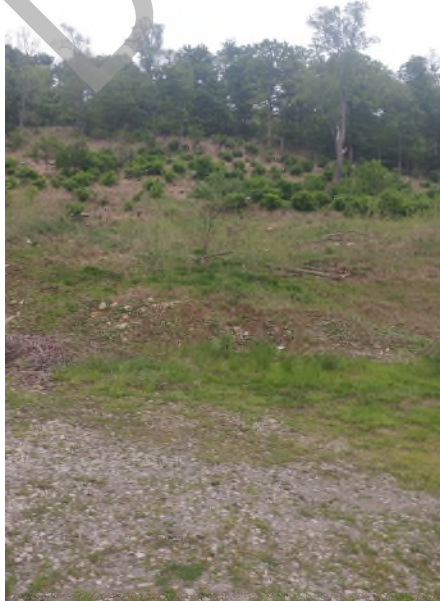
<b>7</b>	<b>Location / Orientation</b>	Slope adjacent to Bethany Pike
	<b>Remarks</b>	Colluvial soil present

<b>8</b>	<b>Location / Orientation</b>	Entrance Roadway from Bethany Pike
	<b>Remarks</b>	Colluvial soils present
