Reference: **Geotechnical Evaluation**  
**GC&P Development Planning Commission Application Review**  
Wheeling, West Virginia  
S&ME Project No. 1195-20-002

## ◆ Introduction

S&ME is pleased to submit the results of our geotechnical evaluation completed for the GC&P Development Planning Commission Application Review in Wheeling, West Virginia. The purpose of this geotechnical evaluation is to review available data submitted as part of the Planning Commission application for GC&P Development and provide you with guidance on geotechnical engineering related items. This report presents our understanding of the project, site reconnaissance findings, document review comments, and additional geotechnical considerations.

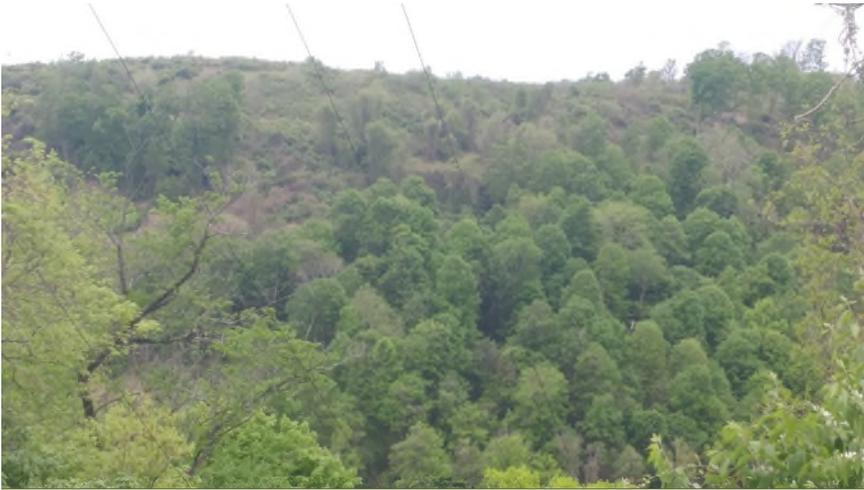
Date: 5/20/2020  Photographer: Richard T. Wilson, PG
<b>1</b>	<b>Location / Orientation</b>	Overview of site
	<b>Remarks</b>	Site mostly vegetated

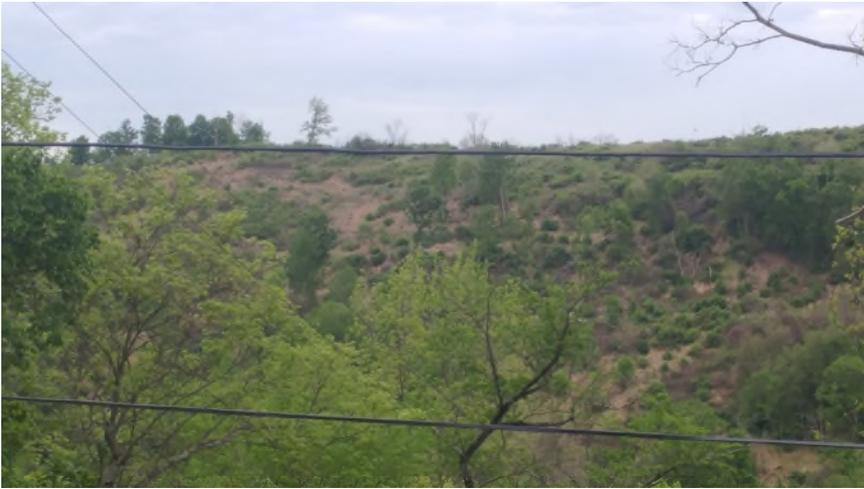
Date: 5/20/2020  Photographer: Richard T. Wilson, PG
<b>2</b>	<b>Location / Orientation</b>	Overview of the site
	<b>Remarks</b>	Site partially vegetated

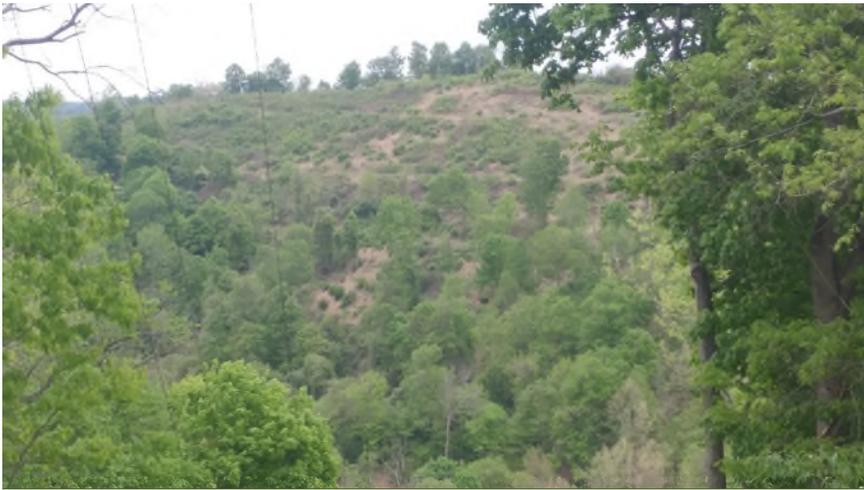
Date: 5/20/2020  Photographer: Richard T. Wilson, PG
<b>3</b>	<b>Location / Orientation</b>	Overview of site
	<b>Remarks</b>	Site partially vegetated

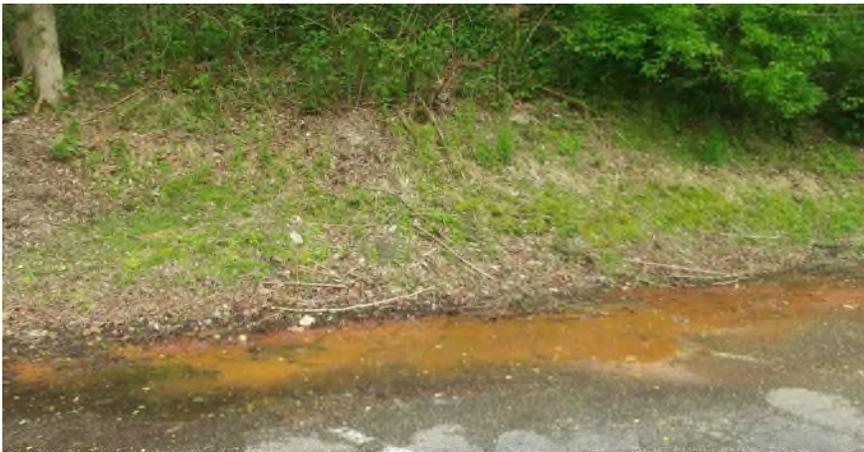
Mr. Richard T. Wilson, PG with S&ME performed a site reconnaissance on May 20, 2020. Mr. Wilson observed significant amounts of colluvium present at critical locations such as Pad A, Pad B, and the multiple entrance roads. Mr. Wilson also observed the presence of stained (orange) water seeping from the colluvium behind the 3C church. The presence of what could be acid mine drainage (AMD) may indicate the abandoned coal mine in the Pittsburg coal seam buried by the colluvium is introducing water into the colluvium. The water would tend to destabilize the soil slope. We are unable to provide an opinion regarding the quantity of the water present in the abandoned mine.

Date: 5/20/2020  Photographer: Richard T. Wilson, PG
<b>4</b>	<b>Location / Orientation</b>	Behind 3C Church, near Station 20 of Profile C
	<b>Remarks</b>	Acidic mine drainage

- ◆ Material being excavated at the development (above approximately elev. 950 ft.) needs to be tested for the potential to generate acidic water. An Acid-Base Accounting should be performed to quantify the risk and serve as a basis for mitigation.

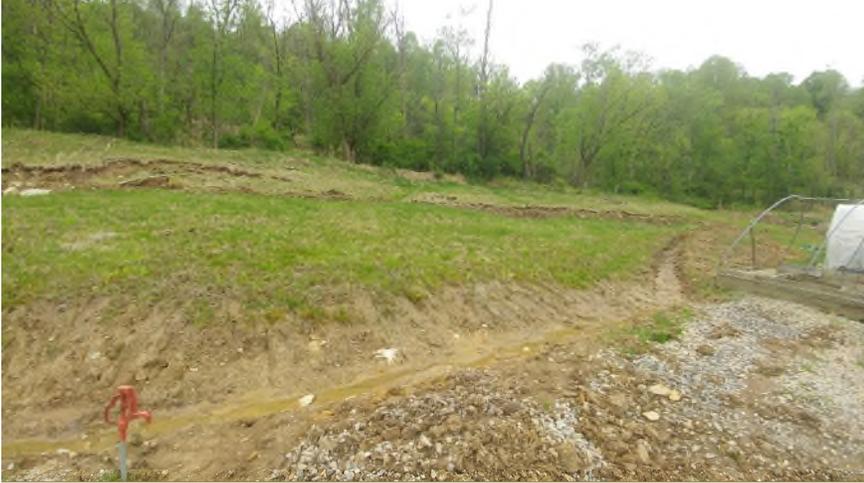
Date: 5/20/2020  Photographer: Richard T. Wilson, PG
5	<b>Location / Orientation</b>	Base of hill near station 30 of Profile C
	<b>Remarks</b>	Colluvial deposits present

- ◆ Additional geotechnical exploration, testing and analyses are required for final design of cut slopes for the development.
- ◆ There is a large amount of colluvial deposits present within the area of influence on the proposed roadways, Pad "A" and Pad "B". We recommend these colluvial areas, and others if identified, that are impacted by the development and its associated activities be evaluated and specific design recommendations developed to ensure the long-term stability of the slopes.

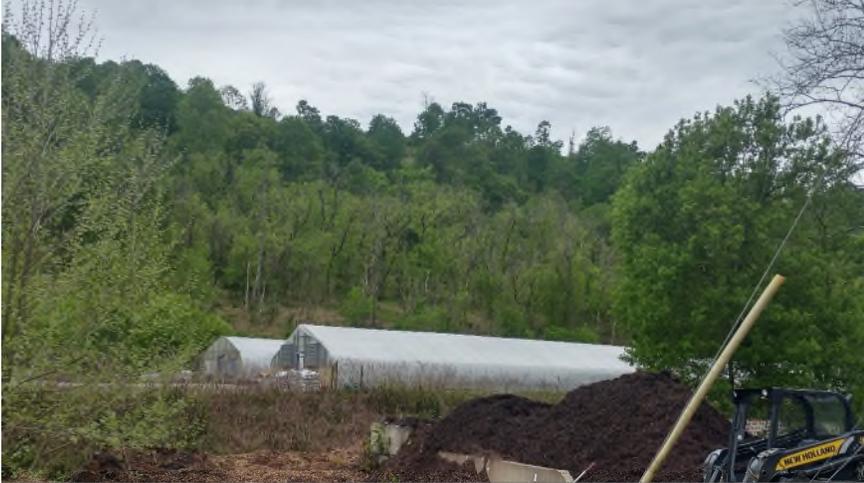
Date: 5/20/2020  Photographer: Richard T. Wilson, PG
6	<b>Location / Orientation</b>	Behind Greenhouse off Waddles Run
	<b>Remarks</b>	Proposed revegetated slope with colluvial deposits

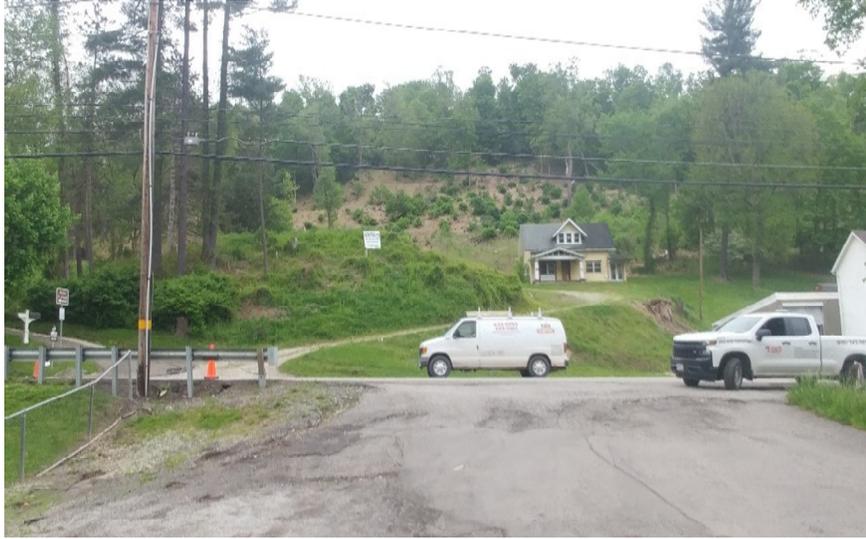
Date: 5/20/2020  Photographer: Richard T. Wilson, PG
7	<b>Location / Orientation</b>	Slope adjacent to Bethany Pike
	<b>Remarks</b>	Colluvial soil present

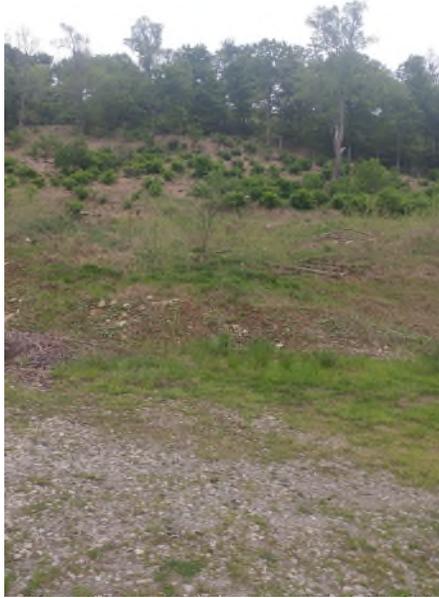
Date: 5/20/2020  Photographer: Richard T. Wilson, PG
8	<b>Location / Orientation</b>	Entrance Roadway from Bethany Pike
	<b>Remarks</b>	Colluvial soils present

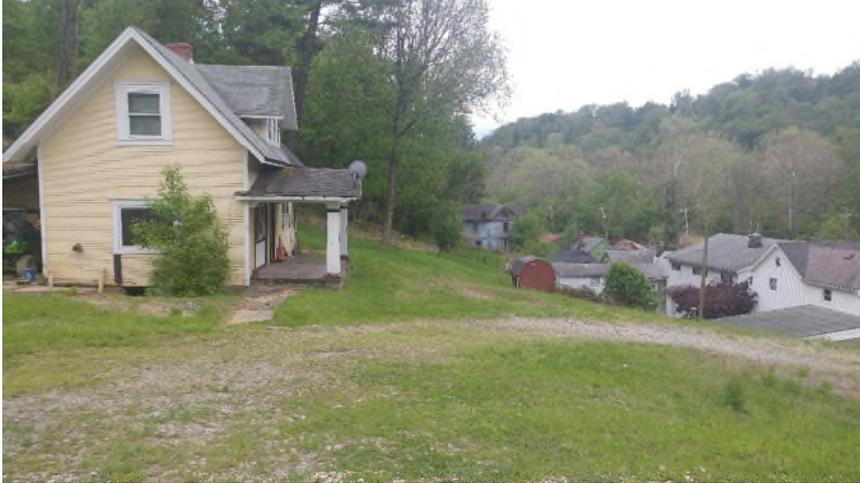
<b>9</b>	<b>Location / Orientation</b>	Entrance Road from Bethany Pike	
	<b>Remarks</b>	Showing colluvial slopes
