## **National Register of Historic Places Registration Form**

1. Name of Property	
historic name N/A	
other names/site number South Wheeling Historic District	
2. Location	
street & number Roughly bounded by 31st Street, 41st Street, Chapline Street and State Route 2 not for publication	ation
city or town Wheeling Vicinity	
state West Virginia code WV county Ohio code 069 zip code 26003

South Wheeling Historic District	Ohio County, WV
Name of Property	County and State

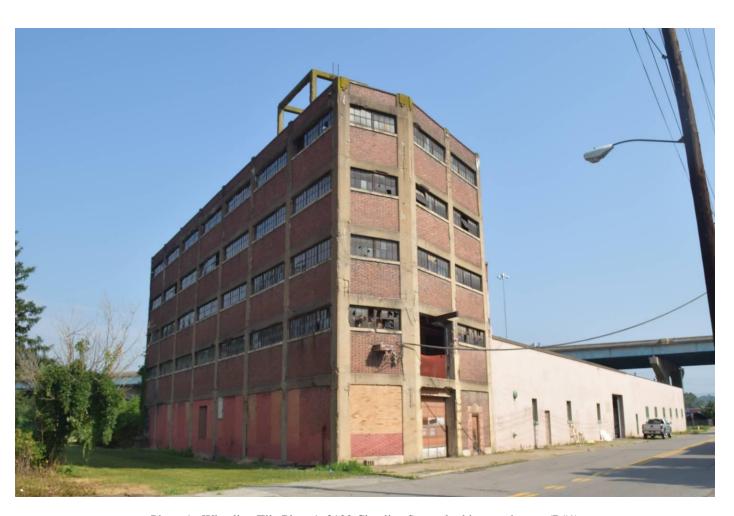
Photo 1. Wheeling Tile Plant 1, 3100 Chapline Street, looking northwest. (R#1)

The original building sits on a sandstone rubble foundation that has been covered with cementitious material, and the walls are constructed of brick. Additions to the northern elevation at the eastern half of the block are constructed of concrete block. The brick tower has a flat roof with parapet walls and is topped by a metal structure that served as the frame for a water tower. The front (western) façade is clad in metal siding and has six irregularly spaced bays. Two aluminum storefront systems with single doors are divided by a double pier. Concrete block stairs with side stairs on each side lead to the entrance door. North of the storefront is a picture window, and south of the storefront is a picture window in a recessed opening that appears to have once held an overhead door. Two openings with overhead doors, one with a concrete loading ramp, are located at the southern end of the façade.

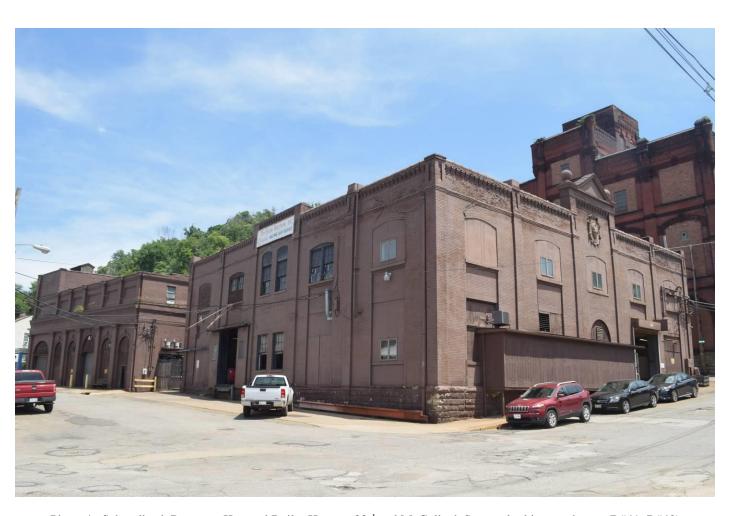
Photo 4. Schmulbach Brewery, Keg and Boiler Houses, 33rd and McColloch Streets, looking northeast. (R#41, R#40)

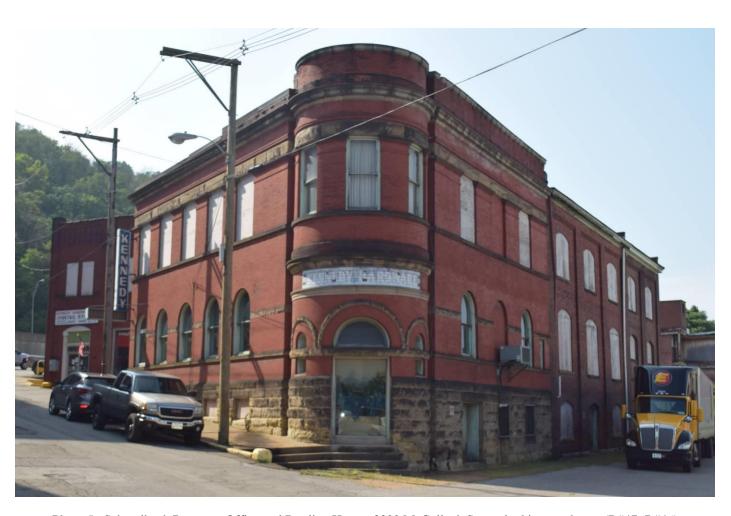
Photo 5. Schmulbach Brewery, Office and Bottling House, 3300 McColloch Street, looking southeast. (R#47, R#46)

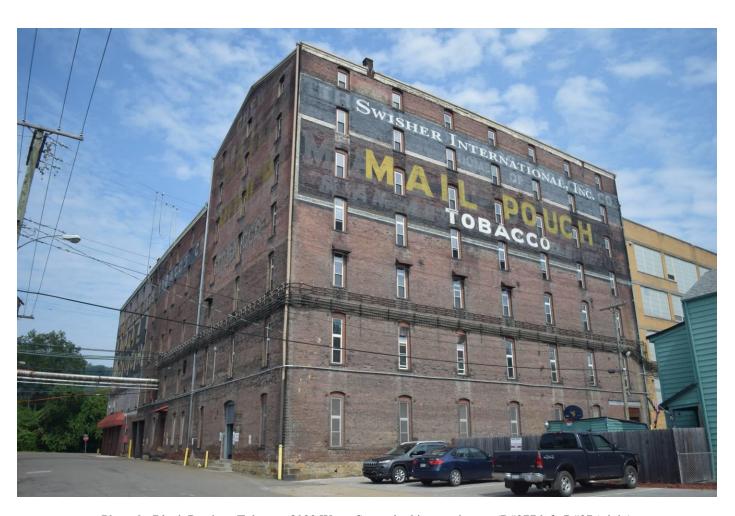
Photo 9. Bloch Brothers Tobacco, 3900 Water Street, looking northwest. (R#277 left, R#276 right)

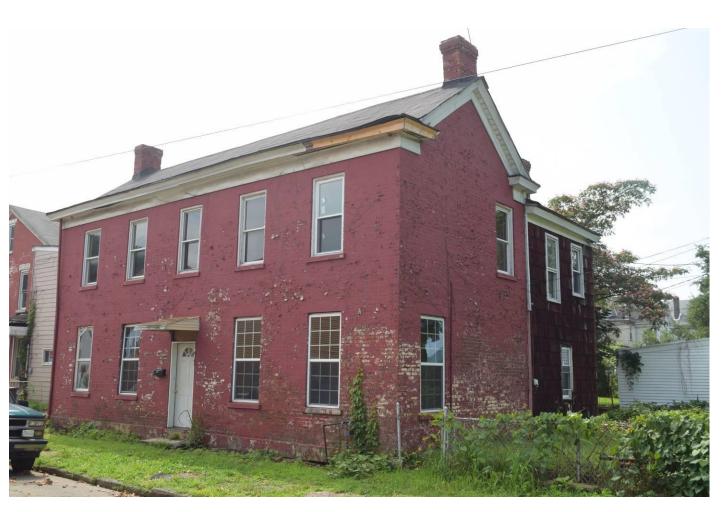
Photo 39. I-house, 6 38th Street, looking southeast. (R#199)

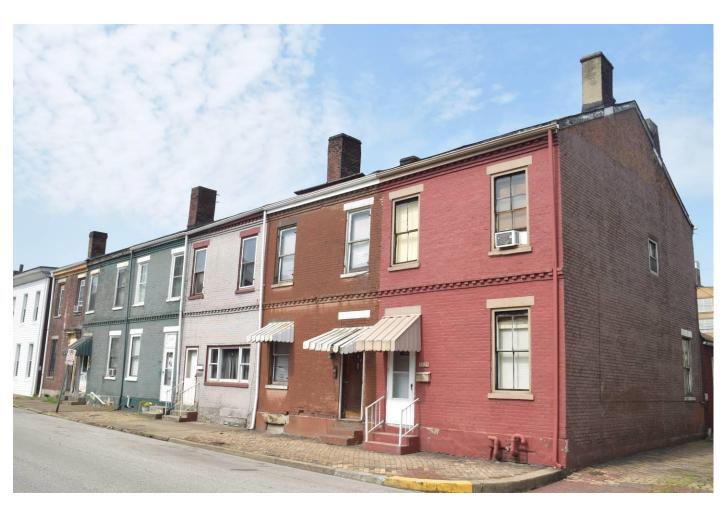
Photo 40. Row houses, 3900 block of Wood Street, west side, looking southwest. (R#312-314, R#316-318)

The residences of the District feature several different types. There are a few rowhouses (R#312-314, R#316-318, P#40) that feature multiple similarly-styled connected residences. Some of the rowhouses that were in existence by 1871<sup>2</sup> were demolished and replaced by individual houses in the later 19<sup>th</sup> and early 20<sup>th</sup> centuries. There are several duplexes and triplexes in the District. Some of these date from the mid- to late-19<sup>th</sup> century, but there are several duplexes that were constructed in the early 20<sup>th</sup> century. Some 19<sup>th</sup> century houses, and nearly all the 20<sup>th</sup> century houses, were built free standing.

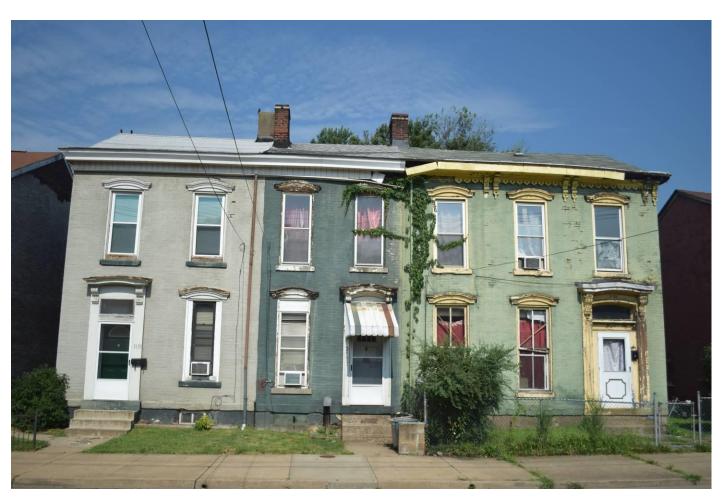
Photo 41. Italianate row houses, 3125-3133 Jacob Street, looking west. (R#113-115)

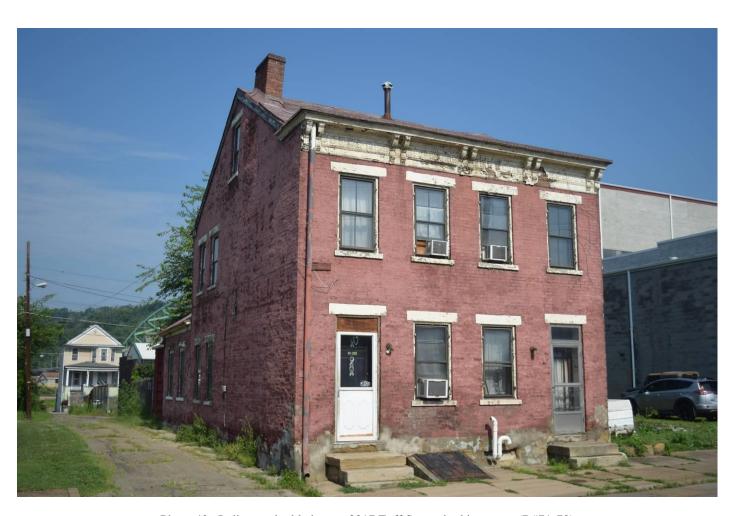
Photo 42. Italianate double house, 3317 Eoff Street, looking west. (R#71-72)

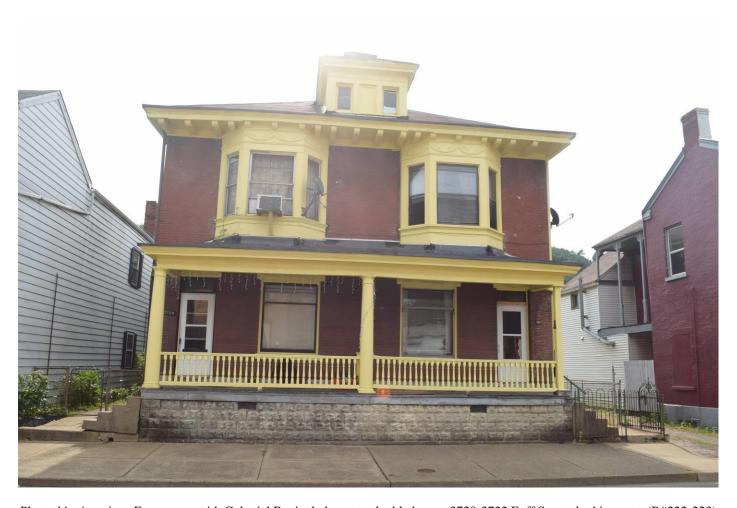
Photo 44. American Foursquare with Colonial Revival elements, double house, 3720-3722 Eoff Street, looking east. (R#222-223)

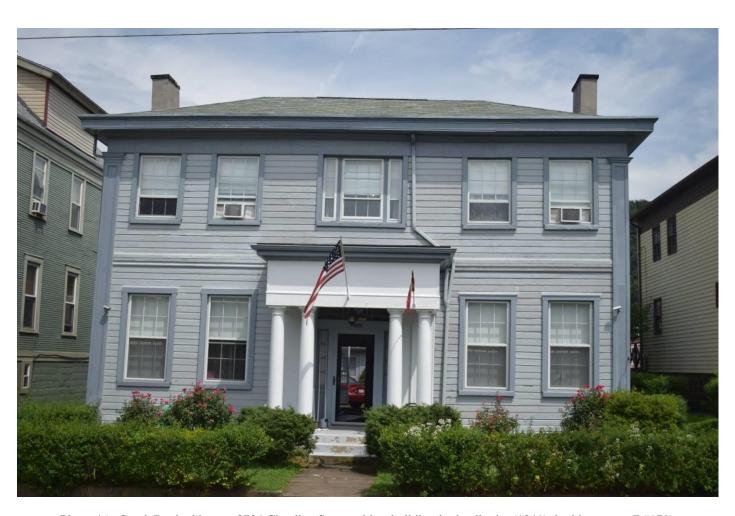
Photo 46. Greek Revival house, 3724 Chapline Street, oldest building in the district (1841), looking west. (R#179)

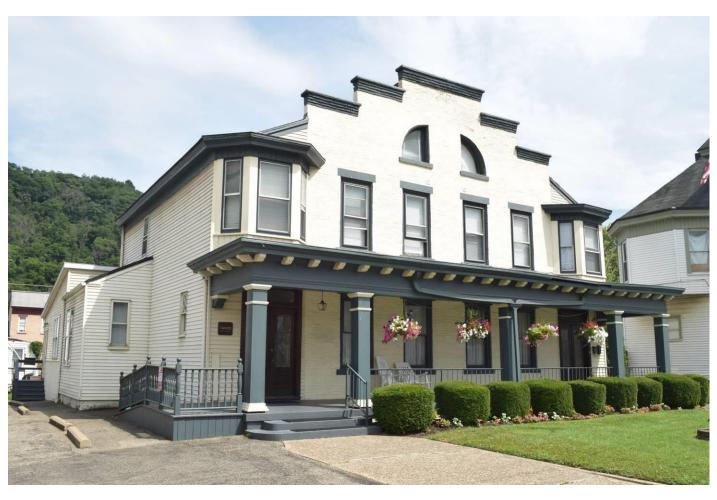
Photo 50. Early brick house (c.1852) with early 20th century modifications, 3828 Jacob Street, looking southeast. (R#269)
