SANDIN E. PHILLIPSON, PH.D.

August 16, 2019

Slope Stability of the Ridge
Bounded by
Woodsdale, Waddles Run, and SR88

Previous Mining and Mine Subsidence Potential

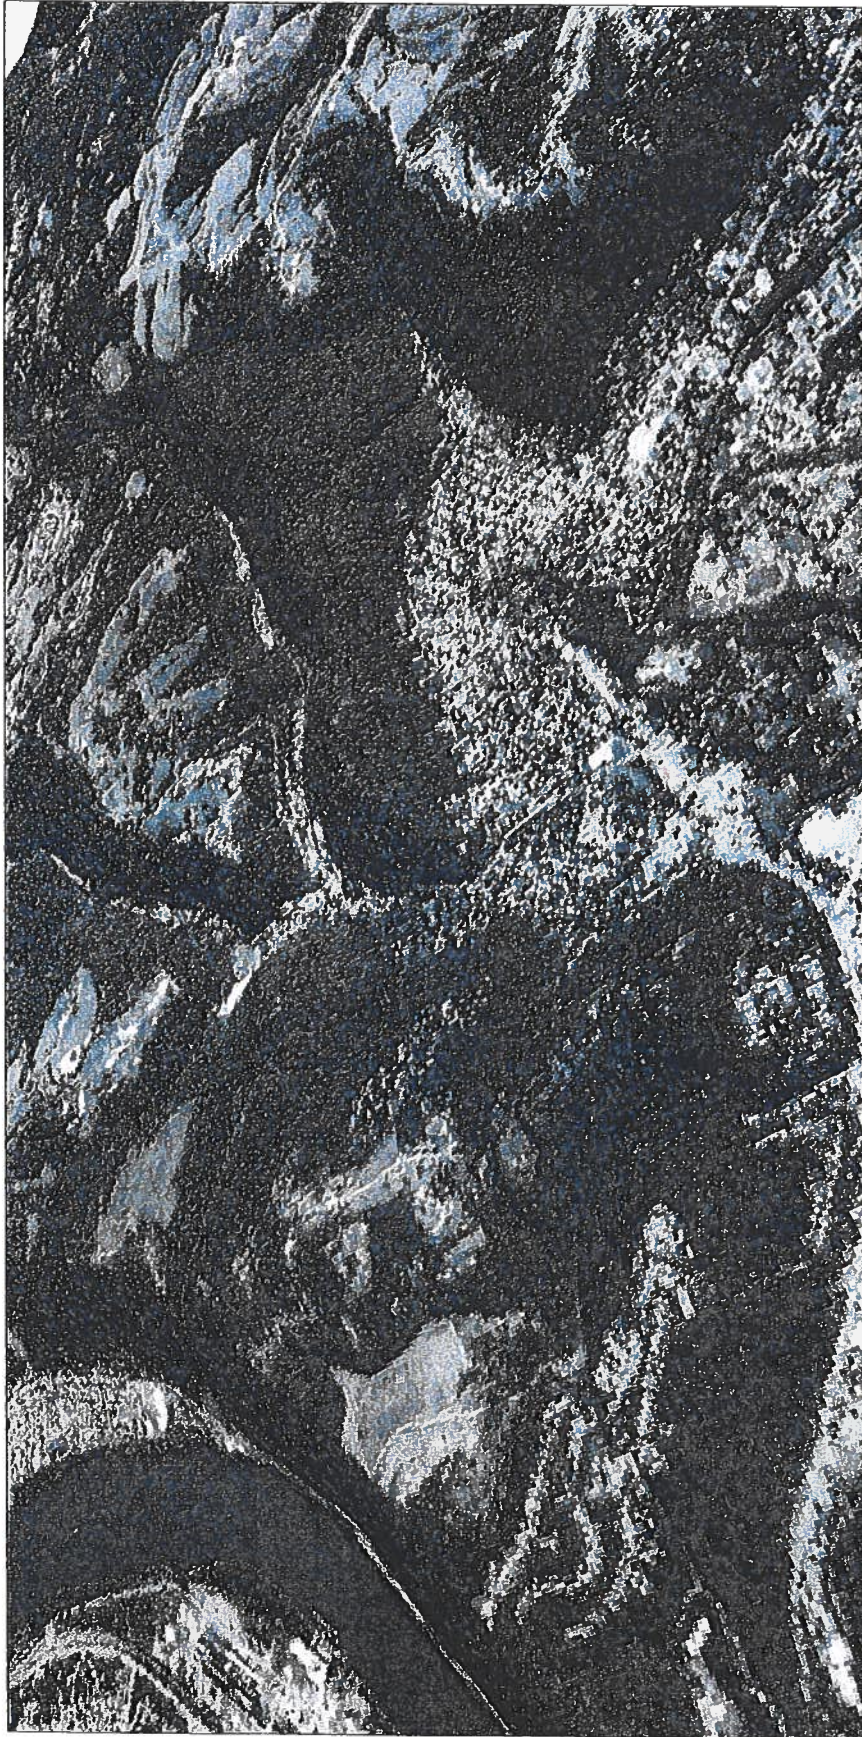
Figure 1. Parcel outlines are shown in relation to the ridge bounded by Woodsdale, Waddles Run, and SR88. Parcel W26-90 includes the spine of the ridge and a significant portion of the slope facing Woodsdale, and comes within 100 feet of Orchard Lane where the slope is 30°. The edge of parcel W32-99.2 coincides with the spine of the ridge.

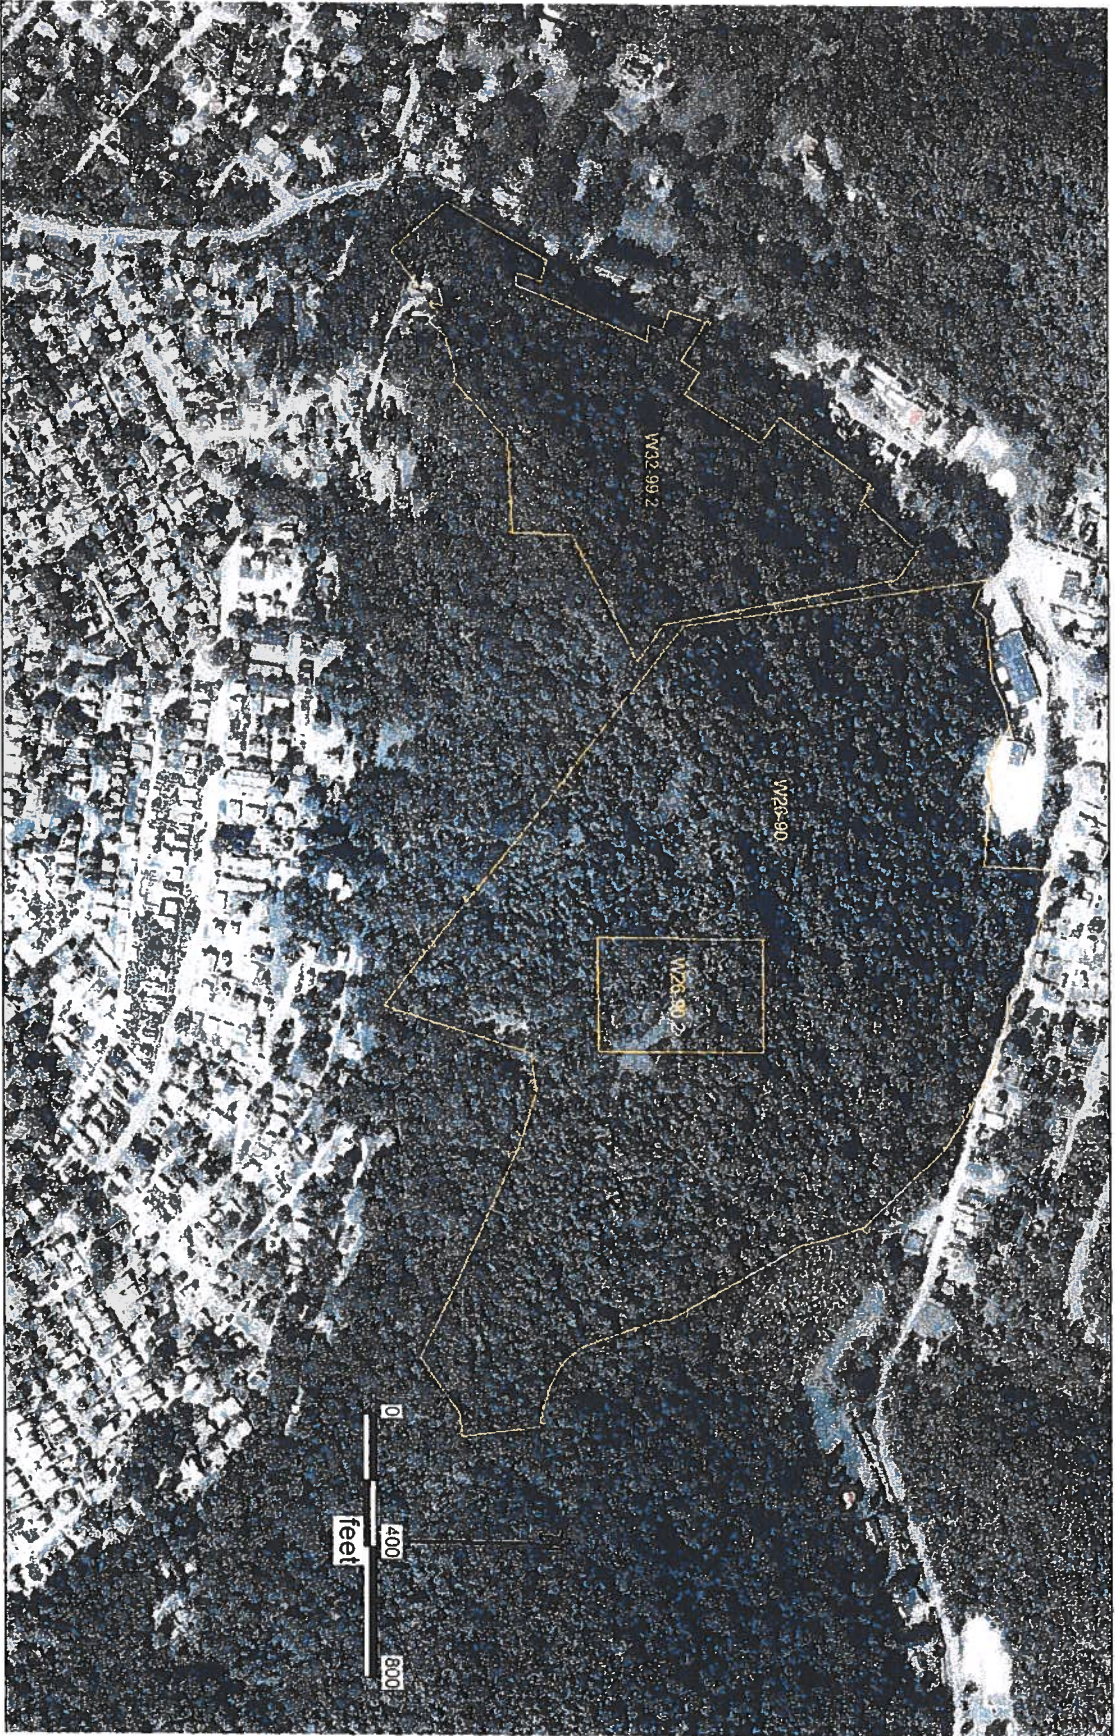
Steep slopes represent a difficult construction terrane for reasons other than the physical operating demands of equipment. As highlighted in the National news by the complete destruction of the community of Oso, Washington, steep slopes represent an inherently unstable environment. This inherent instability was recognized by the West Virginia Geological and Economic Survey (WVGES), which conducted a state-wide study of slope stability in 1976 in order to provide West Virginia homeowners and the State Government with information to guide purchasing and remediation decisions (Lessing et al., 1976). Figure 2 represents an excerpt from landslide mapping performed on the Wheeling 7½-minute quadrangle that characterizes the ridge bounded by Woodsdale, Waddles Run, and SR88 as a "slide-prone area" that was judged to be unstable due to the previous occurrence of landslides, the presence of incompetent rock and soil, and a steep slope. The 1976 study identified landslides that had already occurred on the north and south slopes of the ridge. As will be discussed subsequently, the map presciently and accurately predicted the potential for landslides.

Figure 2. The north, south, and west slopes of the ridge were classified as slide-prone and judged to be unstable by Lessing et al. (1976) as represented by stippled pattern. Pink areas represent older landslides; large red X's represent rock falls; red areas represent recent landslides as of 1976. Parcel outlines are shown for comparison.

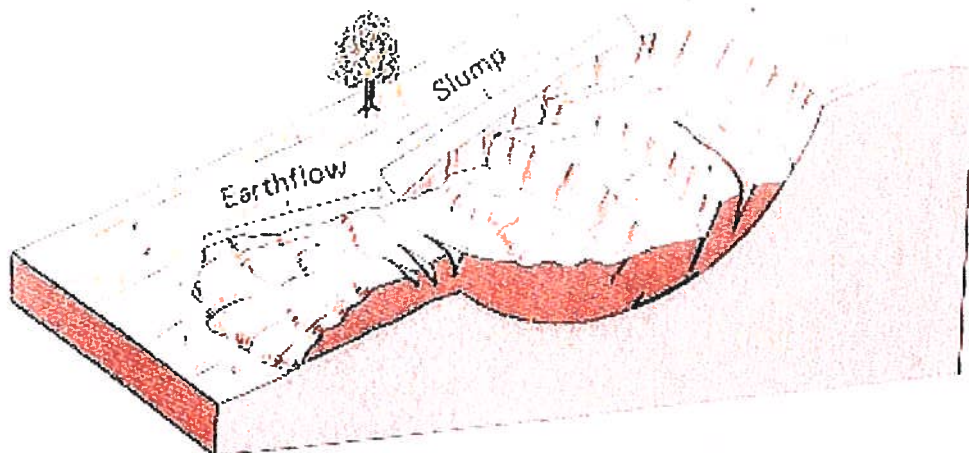
Figure 3. Diagram of a typical slump, showing rotation down-slope and formation of an earthflow at the toe.

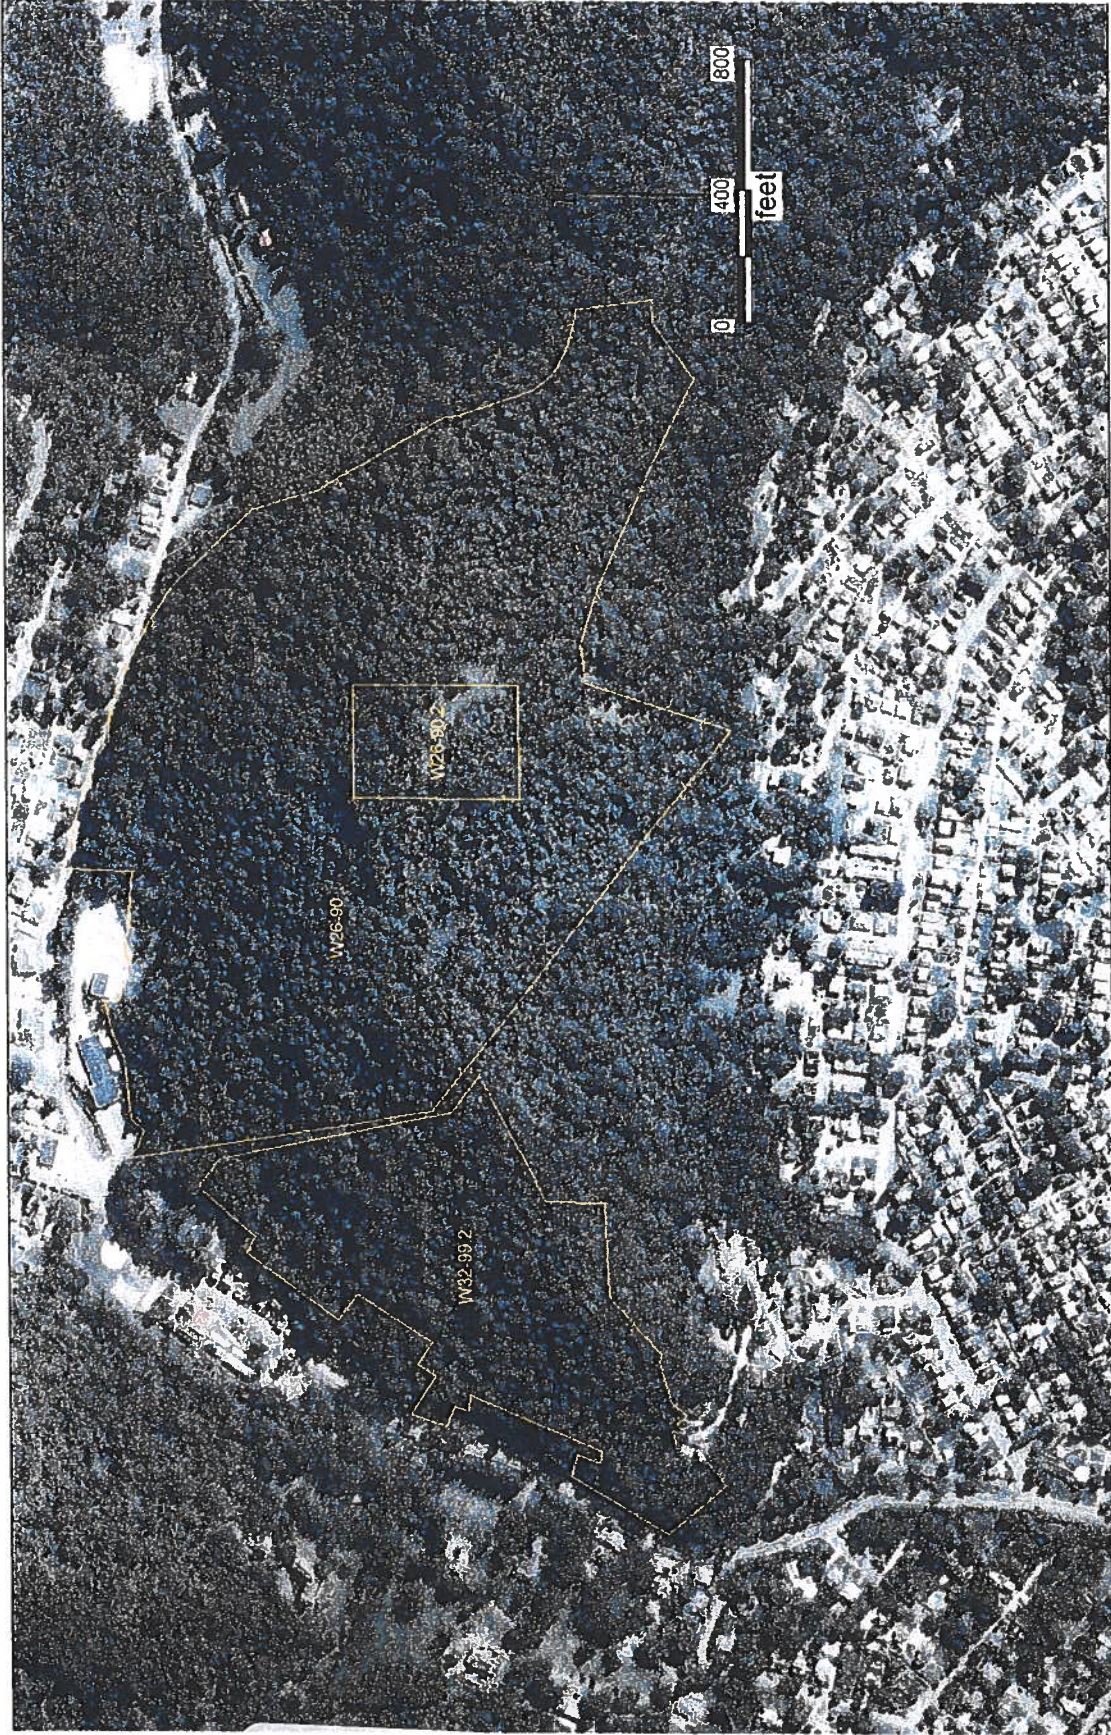
Figure 1. Property boundaries of parcels W32-99.2 and W26-90 are shown in relation to the ridge bounded by Woodsdale, Waddles Run, and State Route 88.

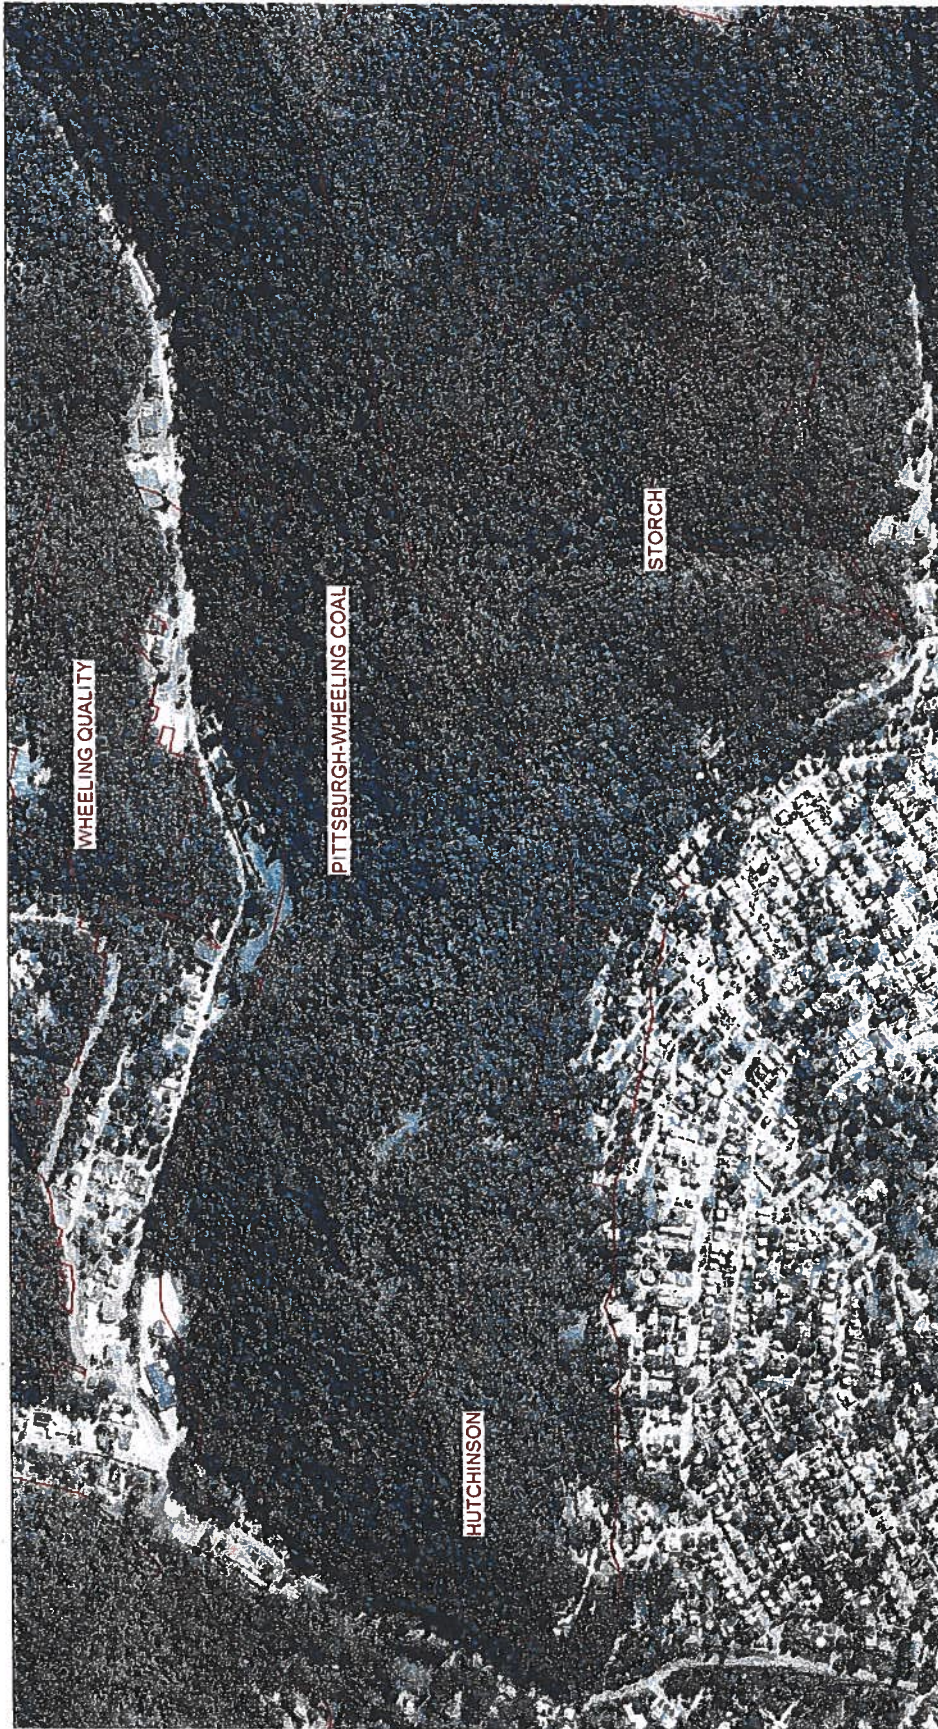
Figure 2. The outlines of underground coal mines are shown superimposed on a 1-meter resolution air photo of the Woodsdale area. The ridge between Woodsdale and Waddles Run was extensively undermined by the Pittsburgh-Wheeling Coal Co.'s Edgewood Mine, the Storch Mine, and by the Hutchinson Coal Co.

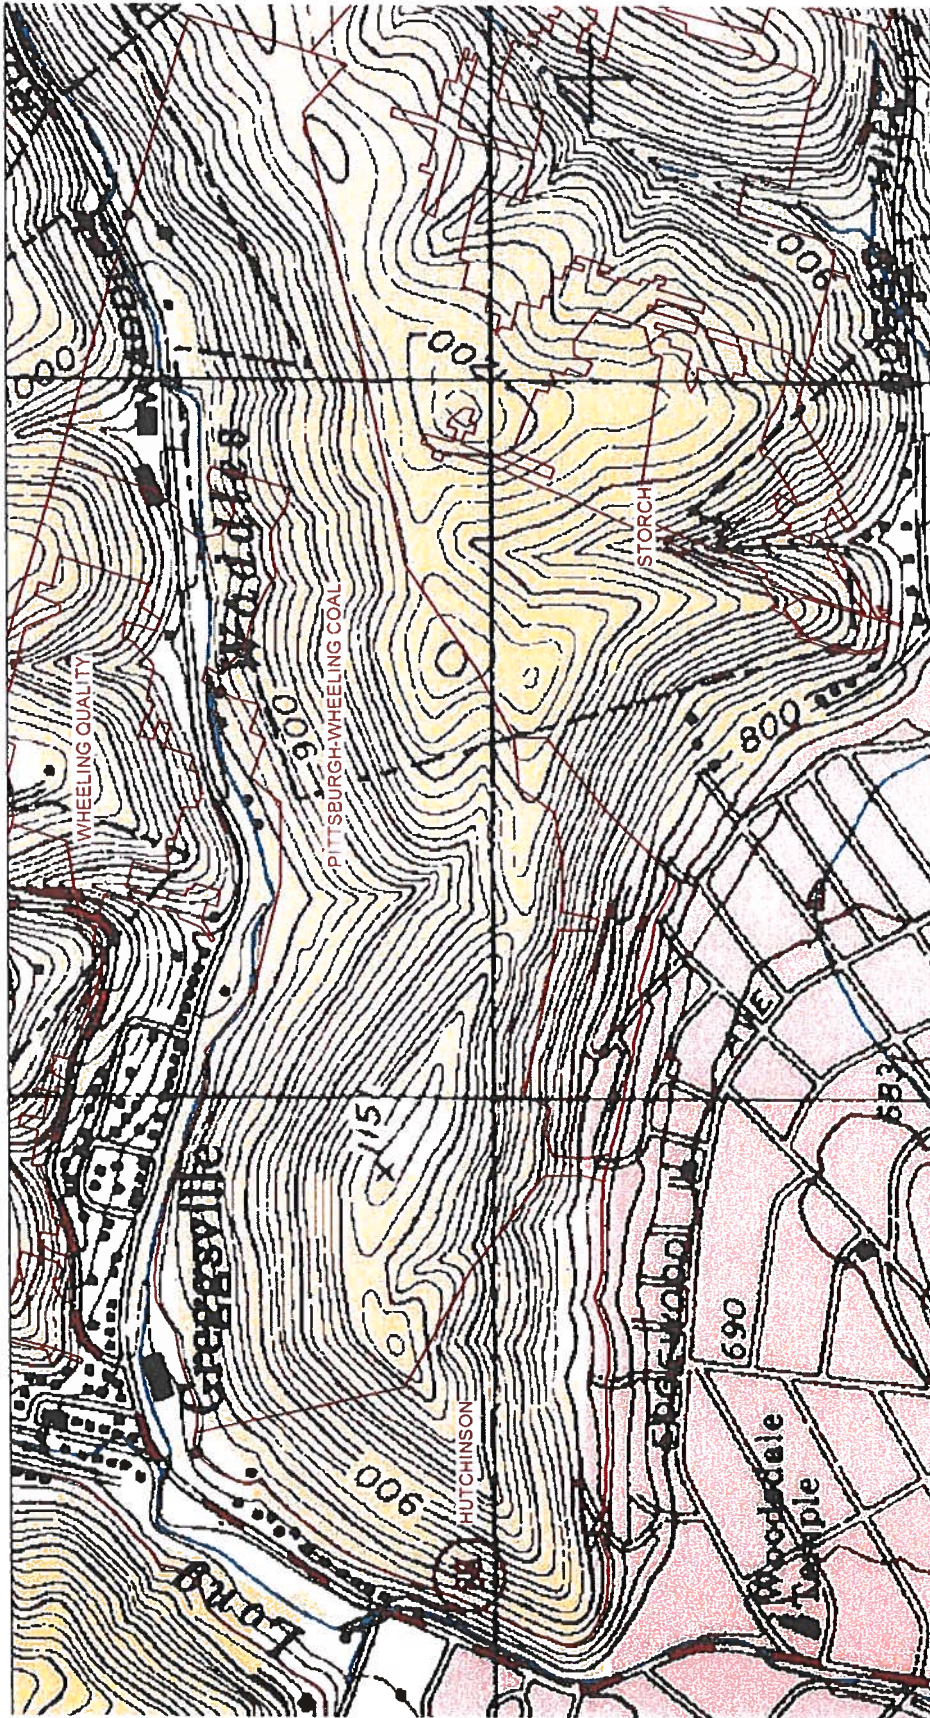
Figure 3. The outlines of underground coal mines (in red) are superimposed on a topographic map that shows the location of the ridge bounded by the Wooddale neighborhood, Waddles Run, and State Route 88. The ridge was extensively undermined by the Pittsburgh-Wheeling Coal Co.'s Edgewood Mine, the Storch Mine, and by the Hutchinson Coal Co. Contours are spaced 20 feet apart vertically, indicating the narrow, steep nature of the ridge.

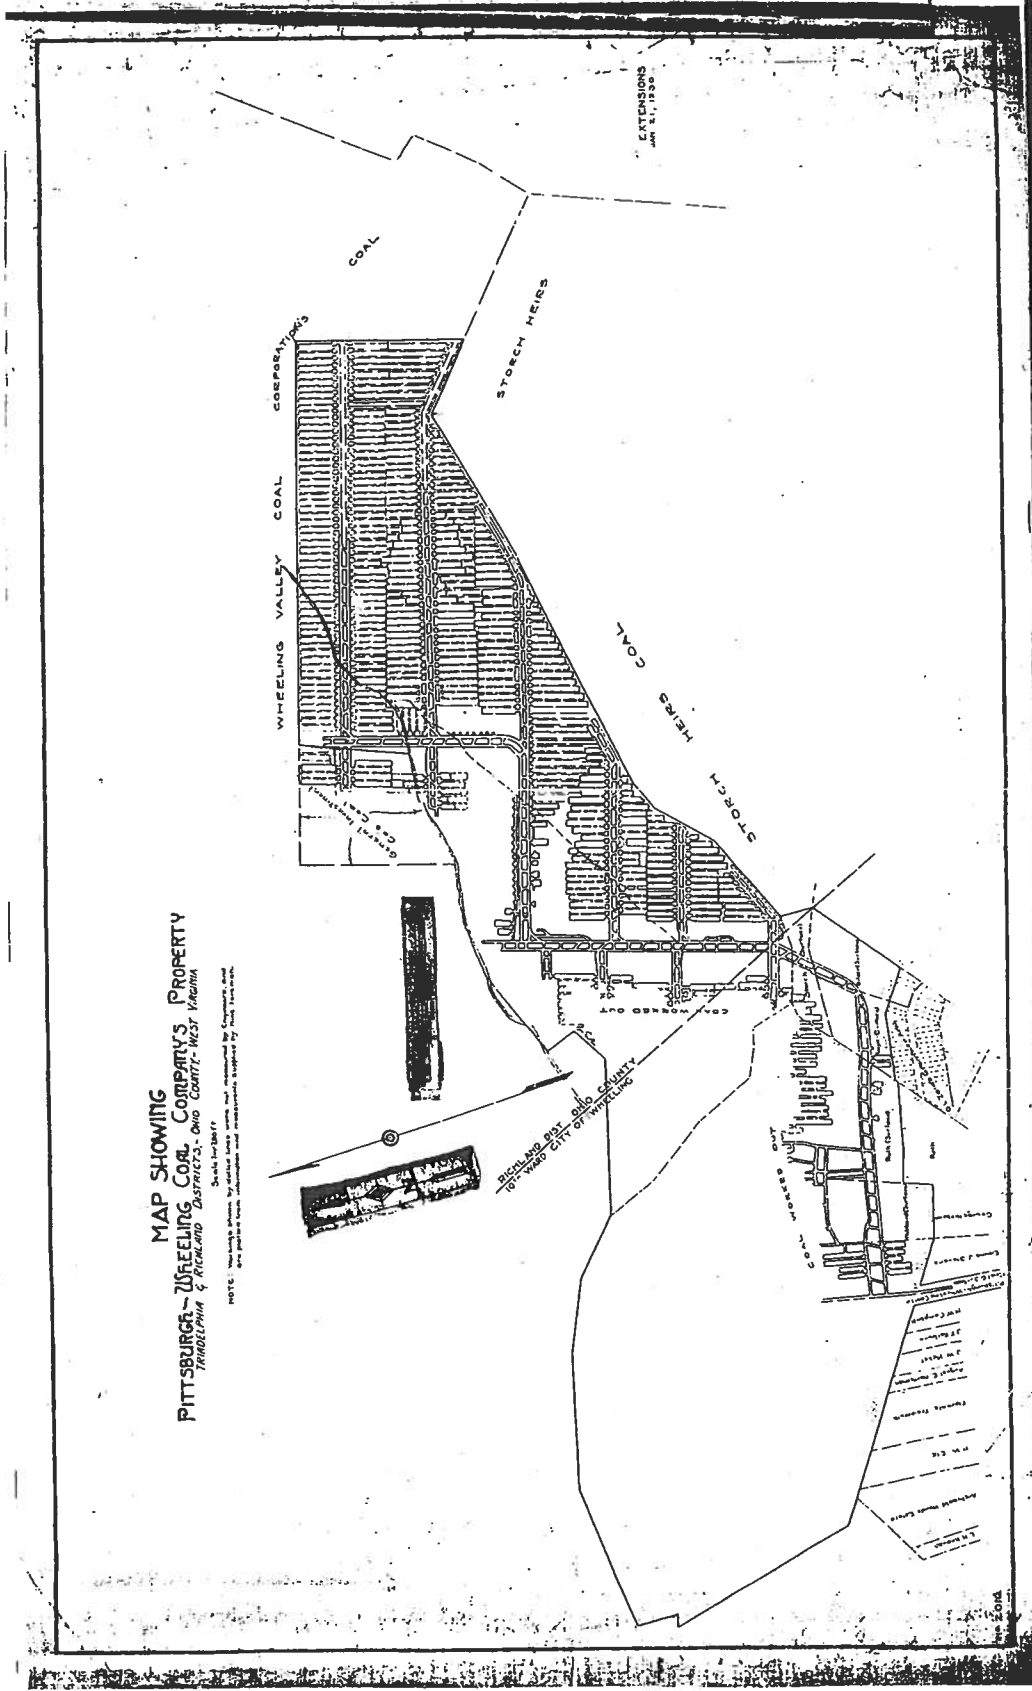
103176v24 28X 365158

The map of the Pittsburgh-Wheeling Coal Co.'s Edgewood Mine (portal located at - 80.68440° E/40.08334° N) obtained from the West Virginia Geologic and Economic Survey indicates that the entirety of the ridge between Greggsville and Woodsdale was "worked out" with no indication of the sizes of any pillars or barriers that may have been left intact to support the weight of the ridge (Figure 4). However, the mine map provides an indication of the mining pattern in workings portrayed to the east, which are likely to have been similar to those in the western half of the mine. In this pattern of mining, the Pittsburgh Seam was accessed by a 2-entry submain used for track haulage. The two track entries are separated by a string of solid coal pillars measuring 65 feet long by 25 feet wide, each separated by a crosscut. Flanking the track entries to the left and right, 250-foot wide panels of essentially unlimited length were driven to the property boundaries. The panels are characterized by long, slender pillars of coal, also referred to as "fenders," that are all that remained of extracting coal from each "room." Each 130-foot long "room" is up to 25 feet wide, separated from the next room by a thin pillar 10 feet in width. The mouth of each room is flanked by a small coal pillar that was left in place to protect the track entries from stress. Together with the large pillar separating the two track entries, the two flanking pillars constitute what is known as a "composite barrier." This composite barrier system is expected to have very high stability, and was intended to resist crushing out in order to protect the track entries from the weight of overlying rock, thereby allowing continued mine access even if the flanking worked-out panels experienced collapse.

Figure 4. The Pittsburgh-Wheeling Coal Co.'s Edgewood Mine, which recorded production of 31,526 long tons in 1907 and operated through the 1920s until about 1930, underlies the ridge between Woodsdale and Greggsville. The large, blank area to the left of the map indicates only that the coal has been "worked out" and there is no indication of the size of any pillars that may have been left to support the weight of overlying rock.

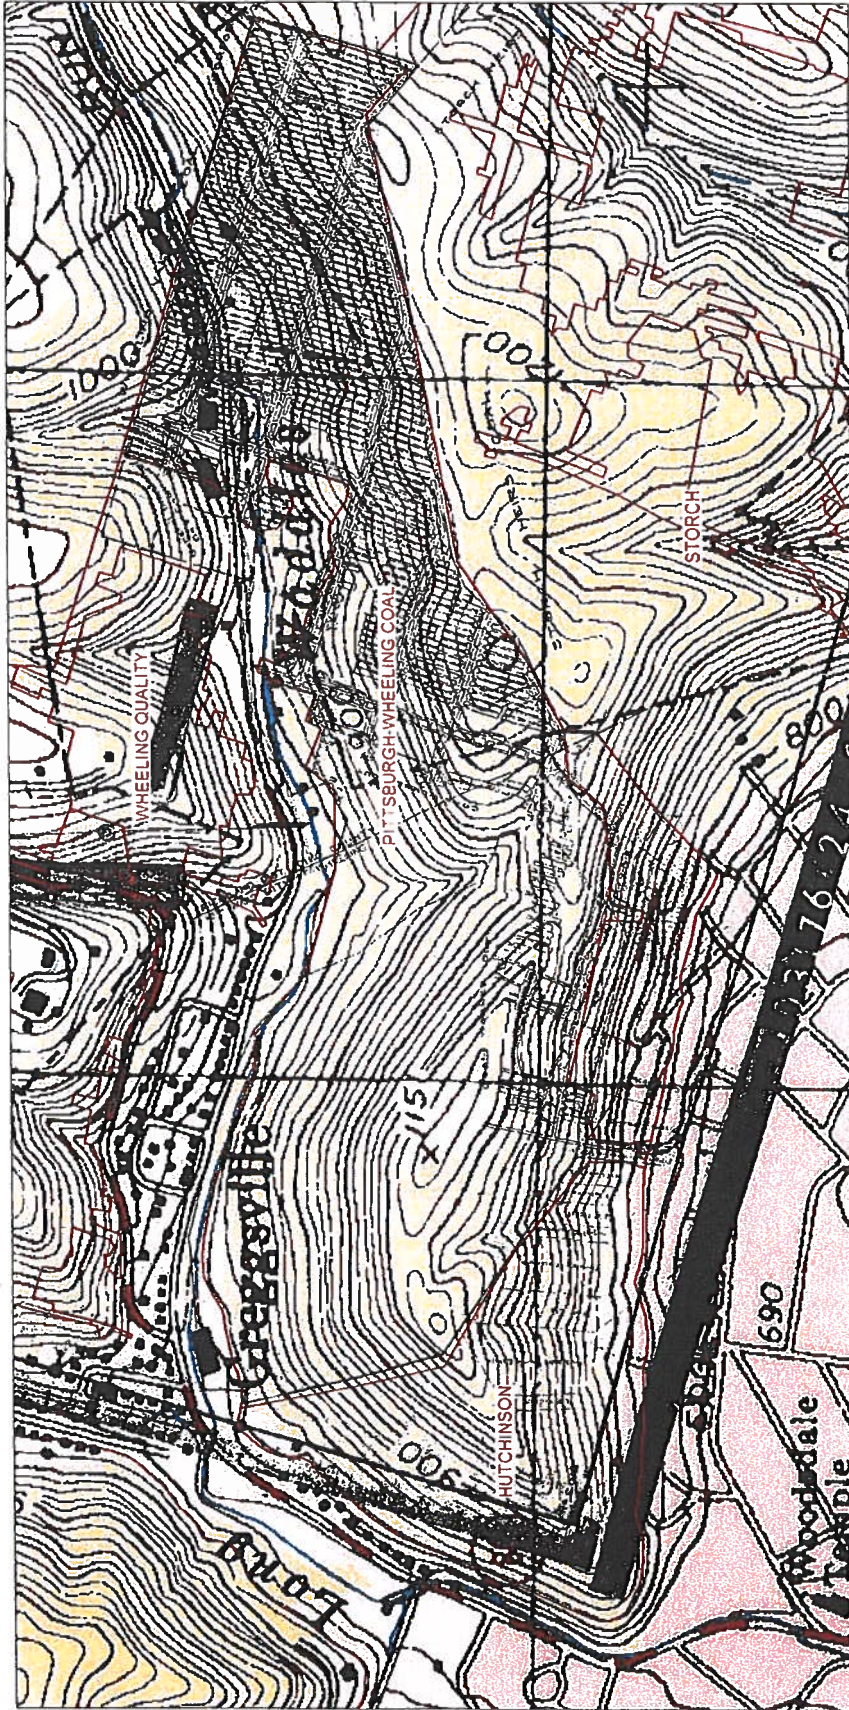
Figure 5. Map of the Pittsburgh-Wheeling Coal Co.'s Edgewood Mine, which operated 1907-1930 and underlies the ridge between Wooddale and Waddles Run. The large, blank area to the left of the map underlying the hill indicates extensive coal removal with no existing map, but is likely of the same pattern as that found to the east.

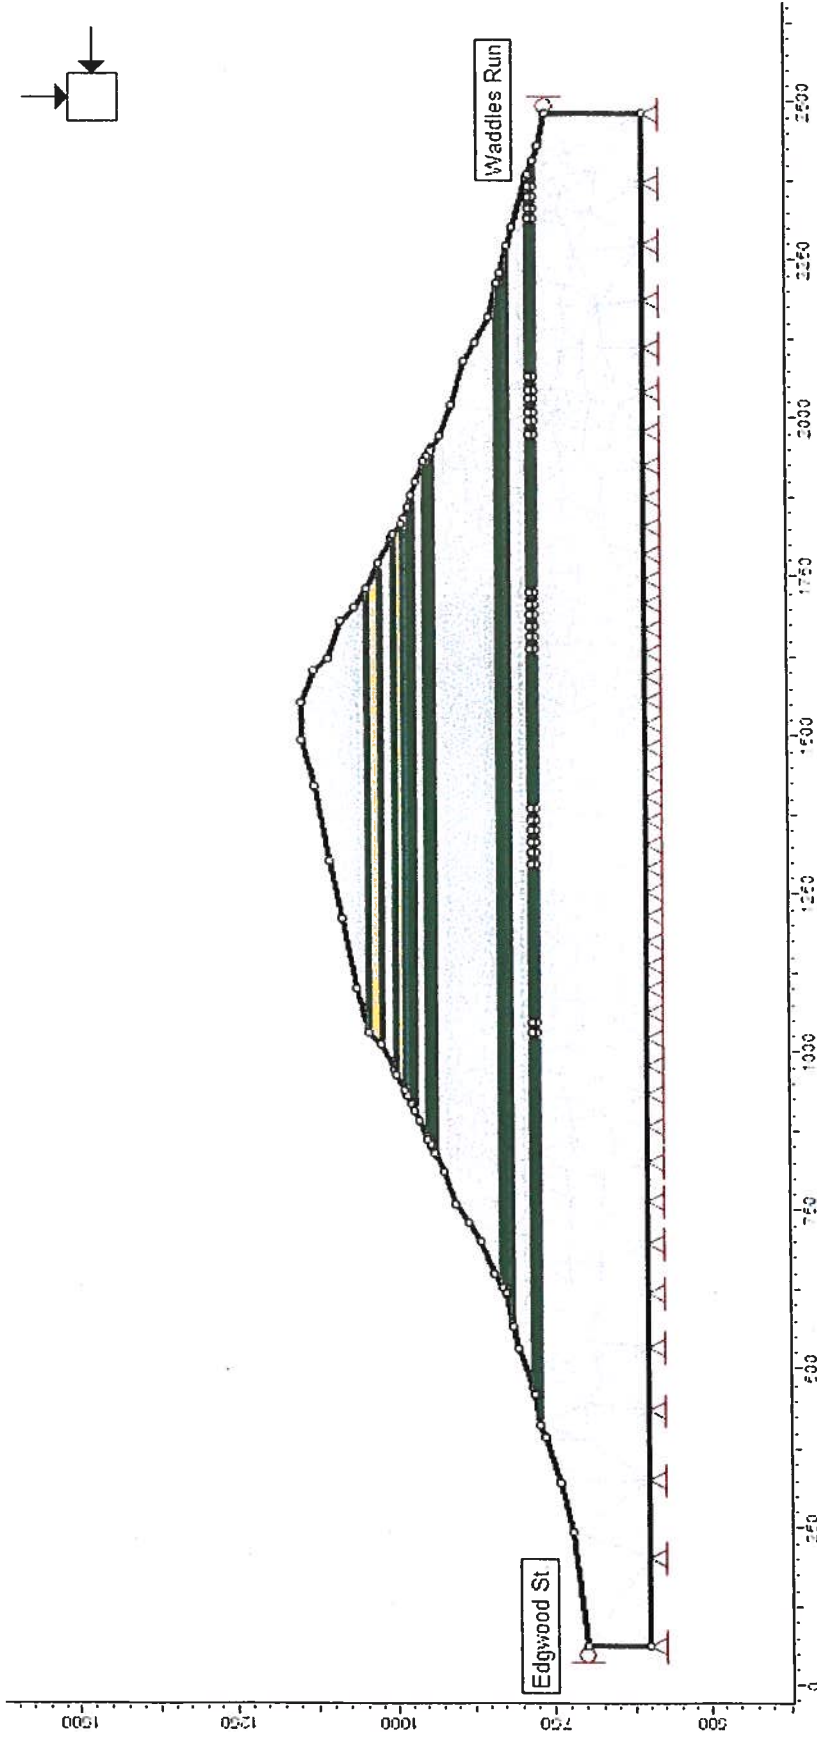
A series of Finite Element Models were constructed for a cross section through the ridge so that the possibility of subsidence could be further assessed. Finite Element Models calculate the displacements between nodes in a digital mesh that is superimposed on an area of interest. Strength properties are entered for rocks and geologic structures, and the computer applies loads, in this case the force of gravity, and calculates the reaction of the system. The model was constructed with the assumption that coal, shale, and sandstone were the only materials present. The thicknesses of shale and sandstone were obtained by direct measurement while traversing up the south side of the ridge. The thickness of coal in the Pittsburgh Seam was obtained from reports of conditions by state mine inspectors that visited the Edgewood Mine and Storch Mine, which are included in the Annual Report of the West Virginia Department of Mines for various years from 1907 through 1922. The topographic profile was obtained by measuring on the topographic map. Thus, a cross section was constructed that incorporates strata thicknesses that comprise the ridge, and the topographic profile between Edgewood Street and Waddles Run (Figure 6).

Figure 6. Cross section through the ridge bounded by Edgwood Street and Waddles Run, incorporating measured thicknesses of shale and sandstone with Finite Element Model mesh in place at a time prior to mining. Vertical scale is in feet above sea level; horizontal scale is in feet beginning from Edgwood Street.

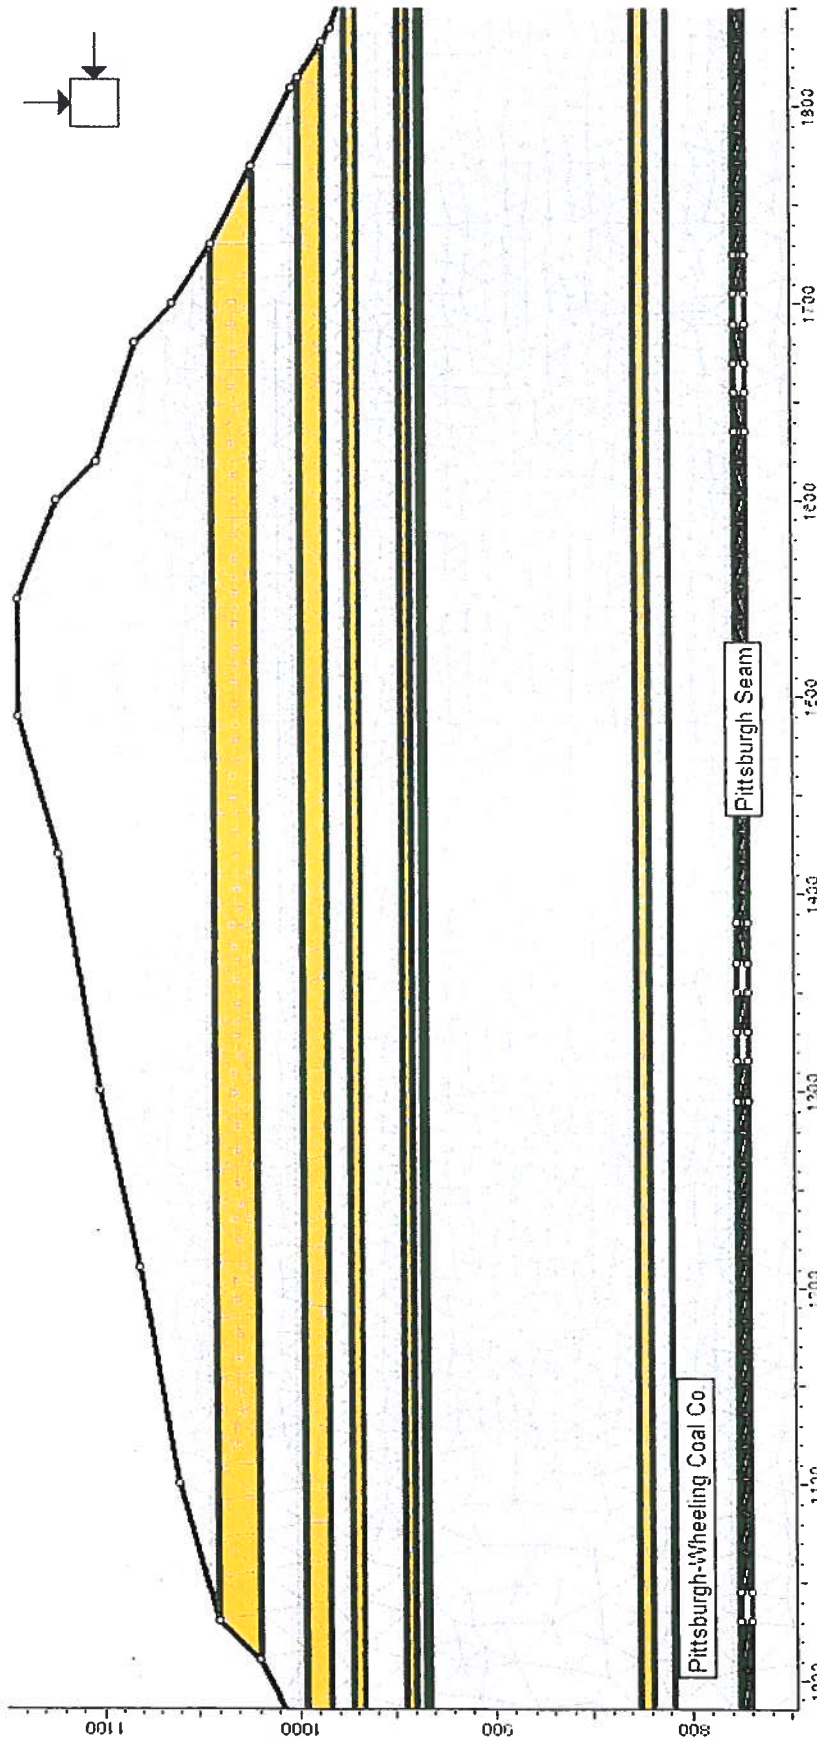
In order to allow the Finite Element Model to calculate displacement and potential failure, three stages were used to represent pre-mining conditions, followed by the excavation of the 2-entry track haulageways, and finally removal of the coal in the production panels (Figures 7 and 8). The very low ARMPS Pillar Stability Factors for

Figure 7. Cross section through the ridge bounded by Edgwood Street and Waddles Run, incorporating measured thicknesses of shale and sandstone with Finite Element Model mesh in place at a time after development of the 2-entry track haulageways, which will provide access to production panels.

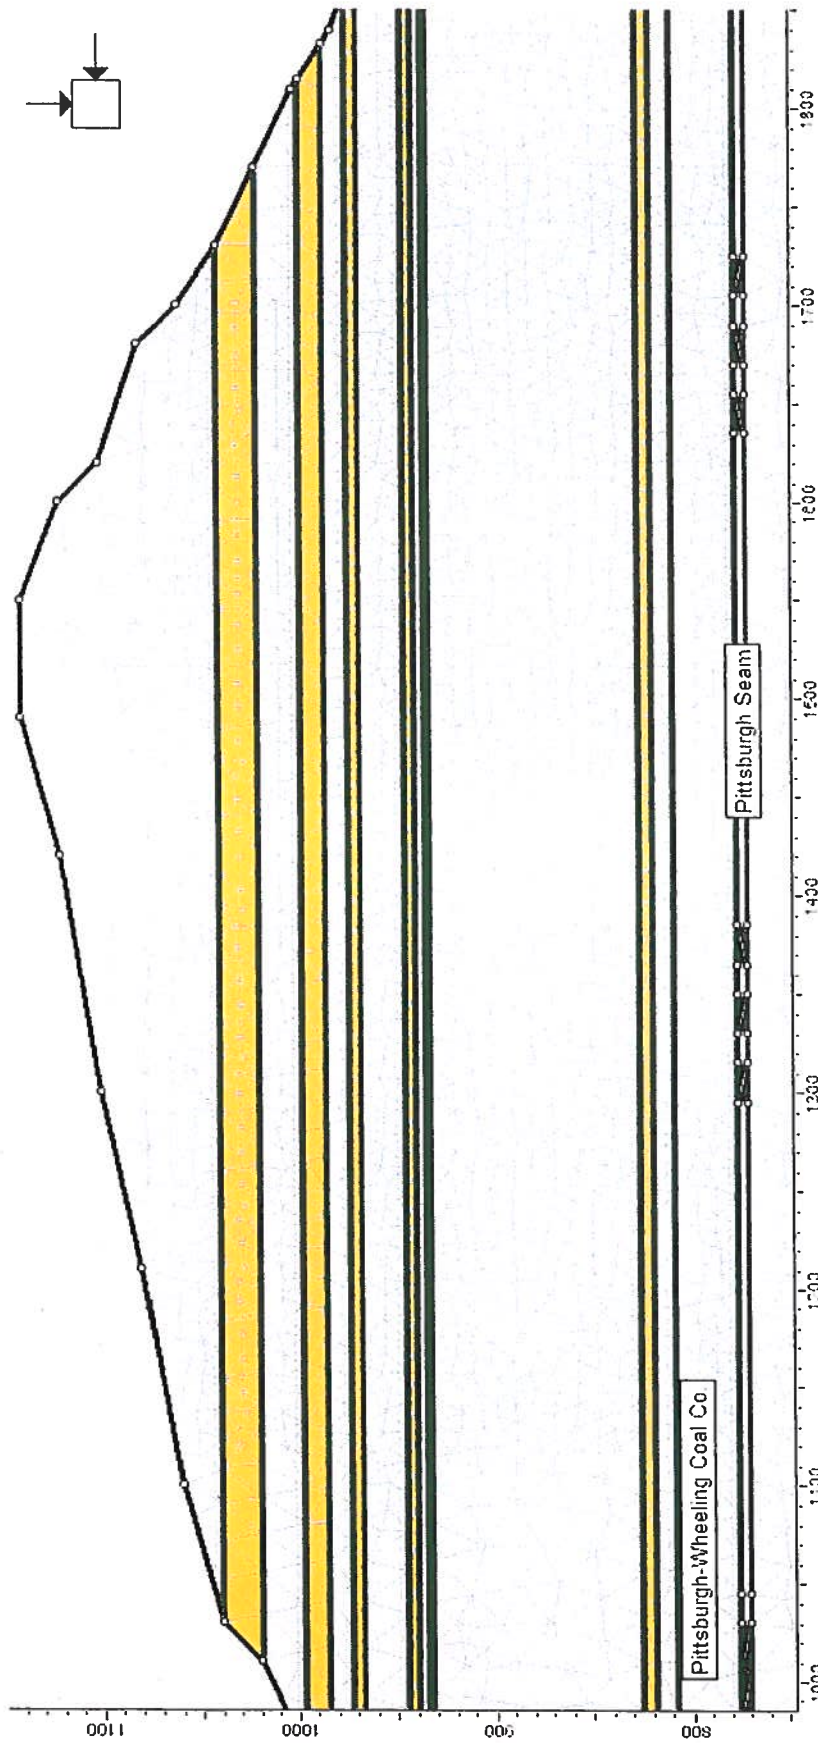
Figure 8. Cross section through the ridge bounded by Edgwood Street and Waddles Run, incorporating measured thicknesses of shale and sandstone with Finite Element Model mesh in place at a time after extraction of coal from production panels that flank the 2-entry track haulageways.

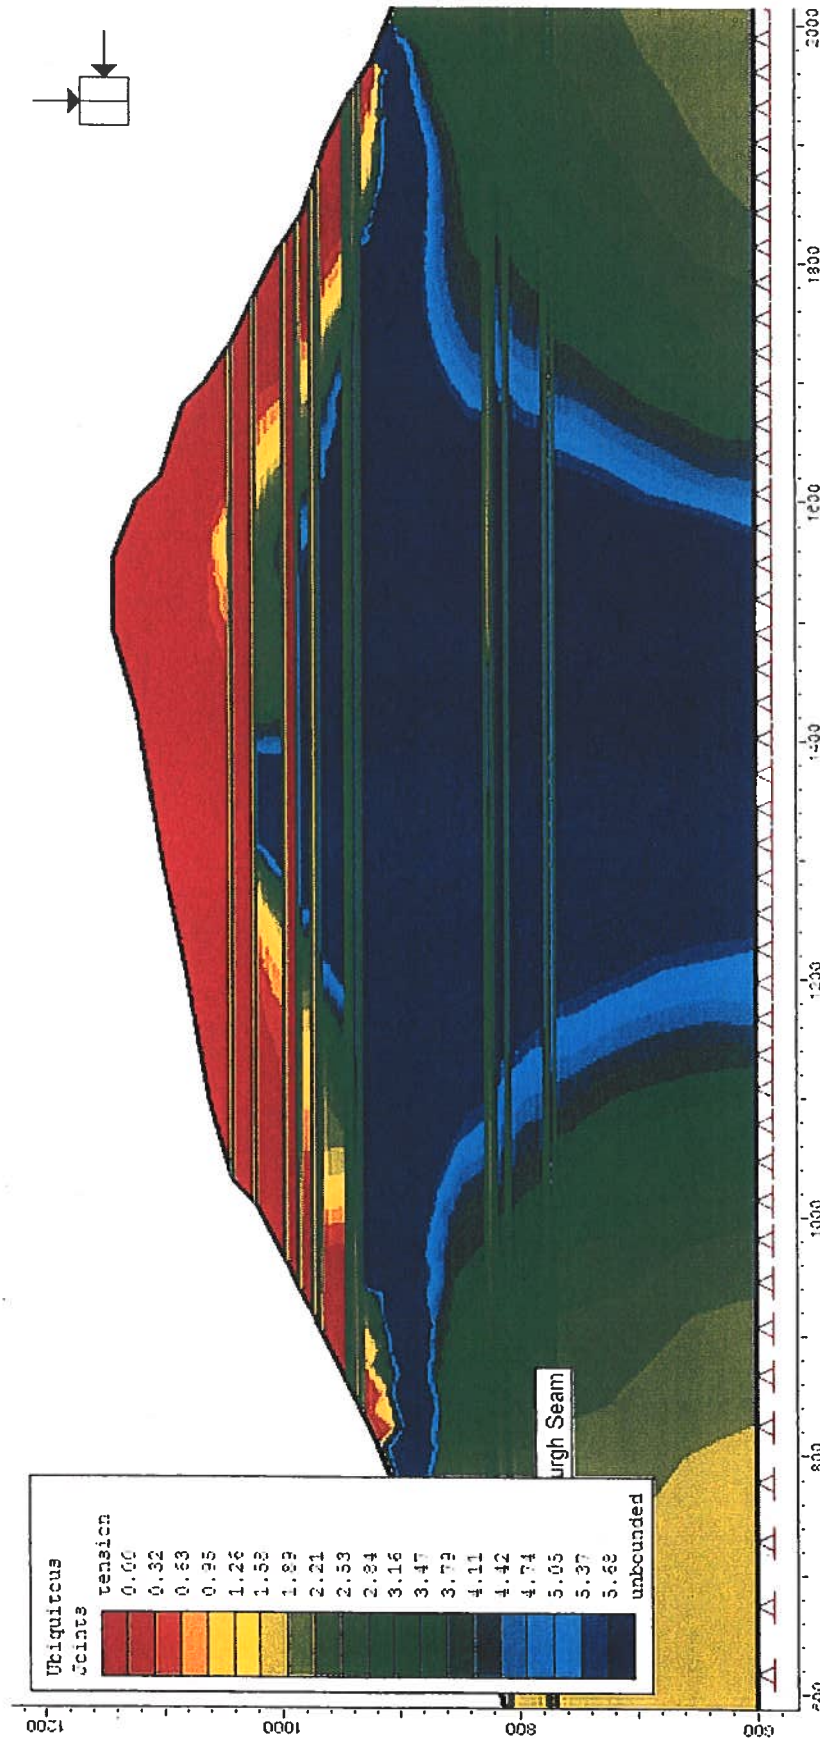
the coal fenders in the production panels indicate that failure is very likely. Complete extraction was therefore assumed for purposes of modeling. If the thin fenders have not already failed, then collapse would now be dramatic. Figure 9 represents the distribution of "Strength Factors" in the calculated mesh displacements for the pre-mining situation shown in Figure 6. At this stage, no coal has yet been extracted, and the model predicts only surface slope movement under the force of gravity at the unconstrained surface of the earth. The models incorporate a feature known as "ubiquitous joints," meaning that joints are assumed to exist everywhere in the rock mass. Based on observations of strata on the ridge, the incorporation of ubiquitous joints is justified because vertical joints were measured in sandstone members. The presence of vertical joints is significant because they dismember the continuity of the strata and reduce or eliminate bridging capability. Figure 10 represents the distribution of Strength Factors for the mining situation shown in Figure 7 in which excavation of the 2-entry track haulageways has been completed. The excavation of these narrow tunnels has virtually no effect on the overlying rock mass because the strata, even when cut by joints, are expected to easily span the narrow openings. Figure 11 represents the distribution of Strength Factors after extraction of coal from the production panels flanking the 2-entry track haulageways. With no stable coal pillars to support the weight of the ridge, joint-bounded blocks are predicted to fail above the 250-foot wide mine voids, with zones of failure reaching the surface. Figure 12 further demonstrates the tendency toward subsidence with the pattern of stress vectors, which all point downward into the voids created by coal extraction in the panels. Finally, Figure 13 supports the interpretation of failure that was indicated by the distribution of low Strength Factors and stress vectors, predicting negative or downward displacement, in other words subsidence, of the top of the ridge above the mine voids.

Figure 9. The distribution of values of "Strength Factor," an indication of failure for values less than 1, for pre-mining conditions assuming the presence of vertical joints in the rock mass. No failure is indicated underground, and only surface failure due to lack of constraint at the Earth's surface is indicated on the ridge slopes.

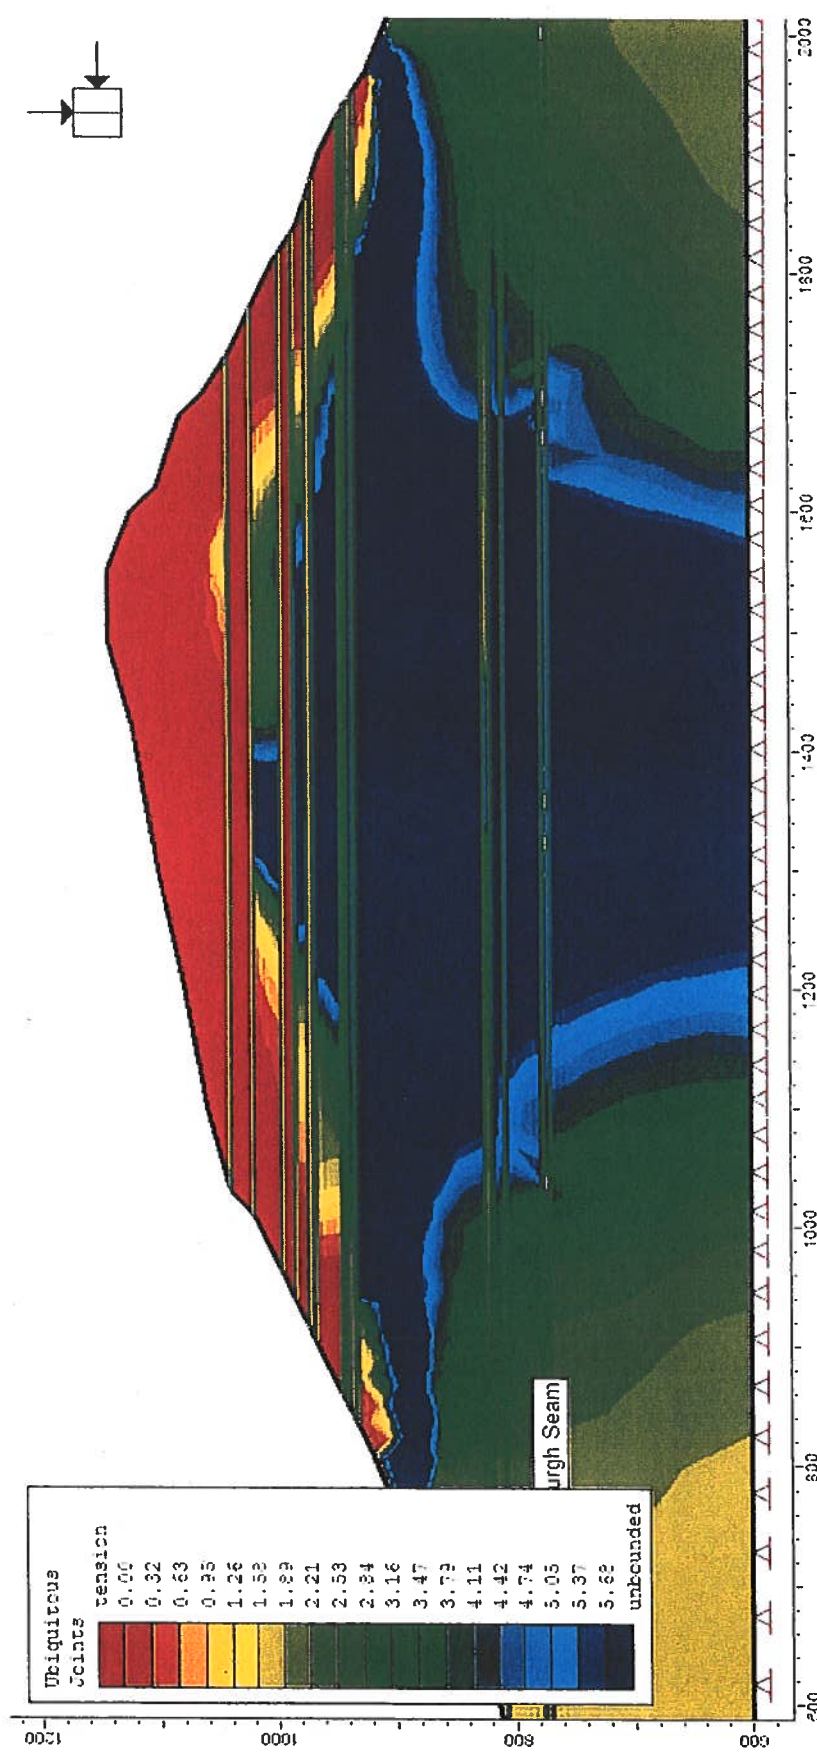
Figure 10. The distribution of values of "Strength Factor," an indication of failure for values less than 1, after excavation of the 2-entry track haulageways assuming the presence of vertical joints in the rock mass. When compared to the pre-mining condition in Figure 9, this limited excavation has virtually no effect on the overlying rock mass.
