SANDIN E. PHILLIPSON, PH.D.

August 16, 2019

Slope Stability of the Ridge
Bounded by
Woodsdale, Waddles Run, and SR88

Previous Mining and Mine Subsidence Potential

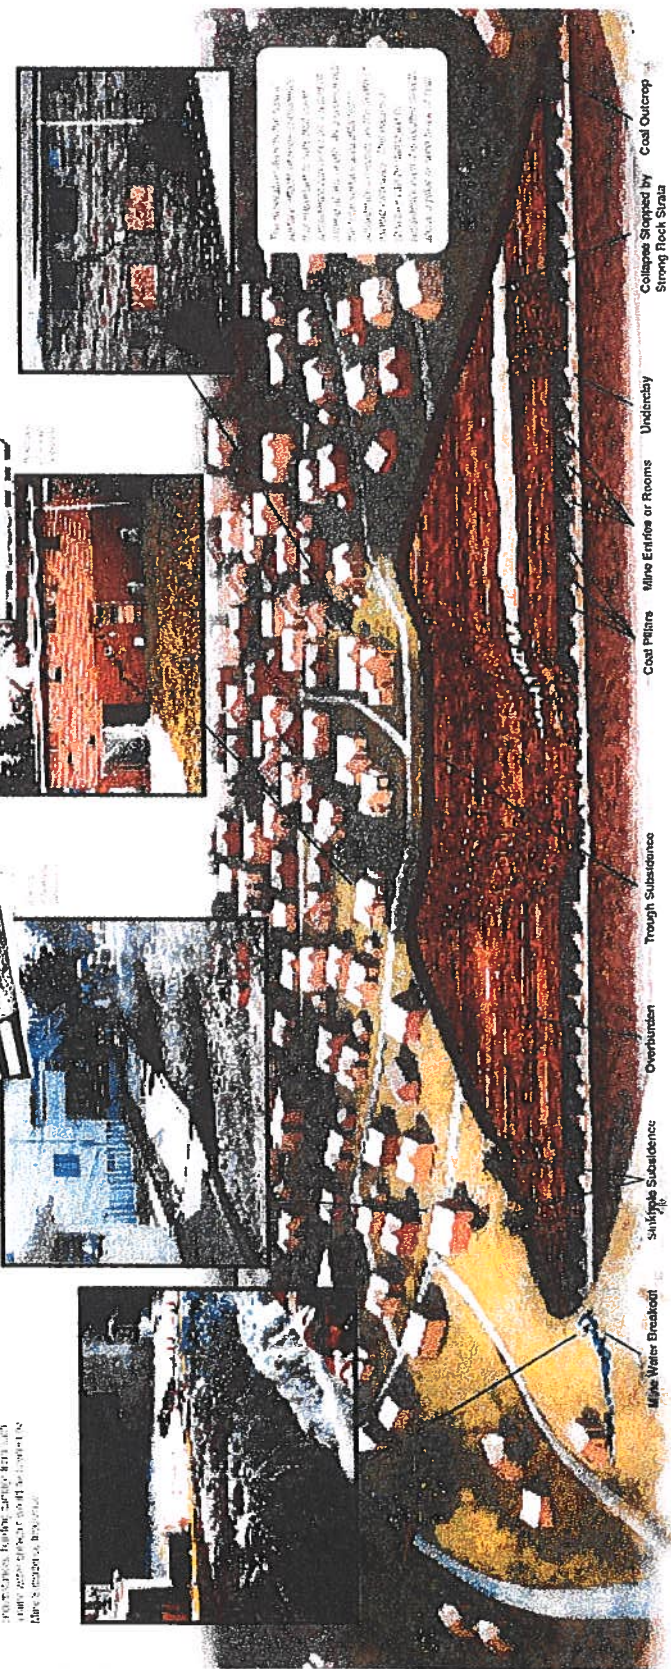
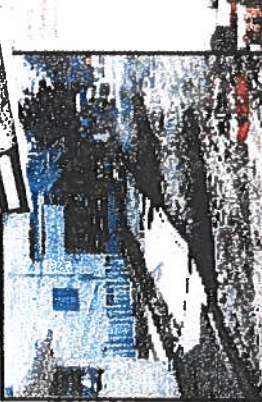
The diagram shows the effects of mine subsidence on the ground surface. It illustrates how the ground can sink or collapse into a void or cavity beneath it, causing damage to buildings and infrastructure. The diagram also shows how the ground can sink into a narrow, elongated void, causing damage to roads and buildings. The diagram is color-coded to show different layers and structures.
